Level 3 Home Survey Report

2nd January 2023

DUNFORD PENROSE SURVEYORS

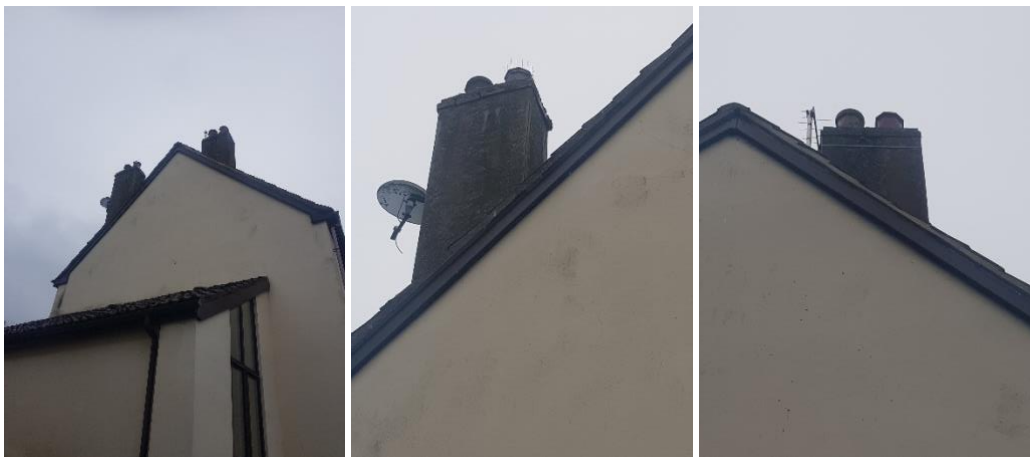
The chimneys appear structurally sound with usual weathering noted. There are two clay pots installed to each chimney, and there is a T.V ariel attached to the front and a satellite dish attached to the rear chimney stack. The weather detailing appears to be in satisfactory condition.

The chimneys appear upright with no signs of any significant bulging, twist or distortion.

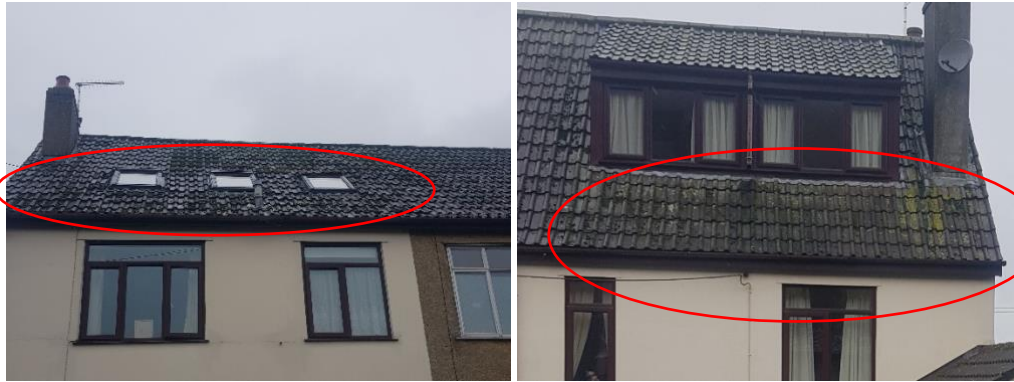
The roof is pitched and ridged and clad with concrete tiles, all in satisfactory condition.

The front roof has three Velux windows, and the rear roof has a Dormer extension with two double glazed windows, all seen to be in satisfactory condition.

There is a significant amount of moss present to both front and rear facing roofs. Water sits in the moss and saturates the tiles inside the internal capillaries, then in weather below freezing, the water expands into ice the tiles shatter or spall. There are various chemical products available to prevent and remove moss though would recommend consulting a local roofing contractor. Do not use, or allow a contractor to use a high pressure hose to remove the moss as it can damage the roof tiles.

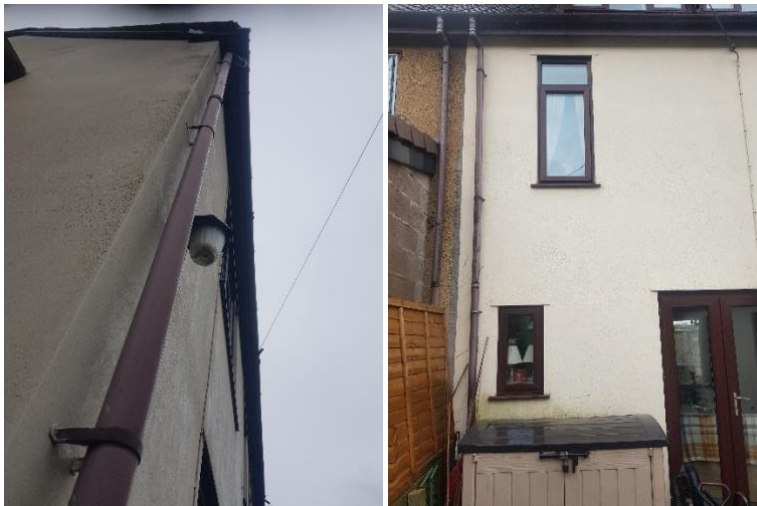
E3 Rainwater pipes and gutters

Guttering and downpipes are of a plastic type and are shared with the neighbouring property. The pipes are believed to discharge into a main drain, but this should be confirmed by your Legal Advisor during pre-contract enquiries. Rainwater goods appear to be adequately aligned with no signs of any significant twisting or distortion noted. A suitable number of support brackets appear to have been provided at regular intervals. Rain was falling heavily during the inspection and no overflowing or leaks were noted.

It is recommended that you allow for routine inspection and cleaning out of the gutters, gullies and downpipes at least once a year.

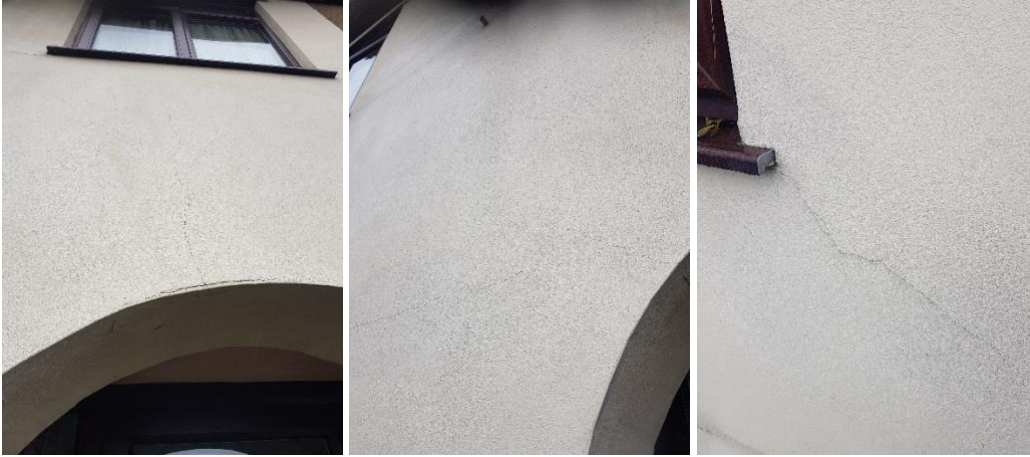
Small thin cracks to the render were noted to the front elevation above the main entrance, and to the right of the front ground floor window below the sill. Water can access these cracks, then in weather below freezing, the water expands creating further damage and water ingress resulting in damage to the interior of the building. The cracks did not appear to be replicated internally. There are a number of possible causes for these cracks and are currently common following the unusually warm summer.

We recommend that a contractor is instructed to break into the cracks, clear out debris, fill with a suitable product and decorate. During this process the contractor should be asked to check the condition of the bricks and mortar beneath then further monitor over the next 6 months.

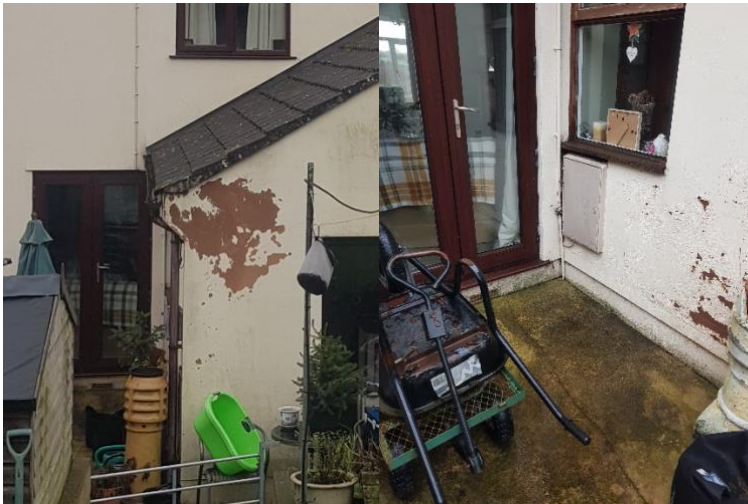
The render to the exterior wall of the kitchen is badly weathered/worn and is in need of decoration to prevent further damage and water ingress.

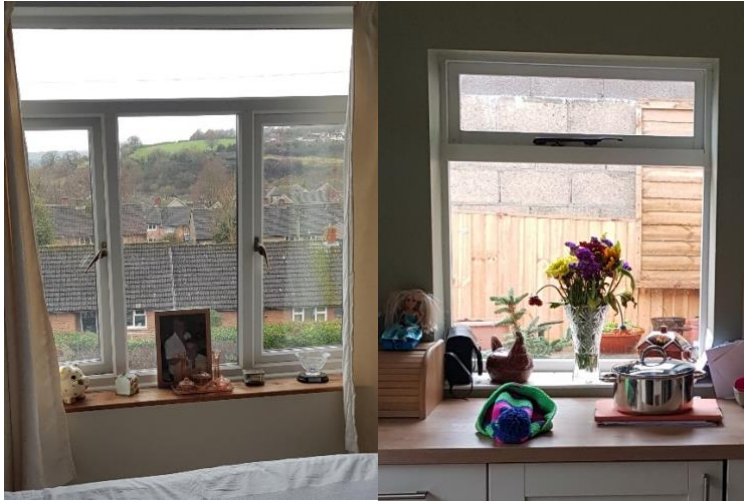
The windows are mainly double glazed, white internally and brown externally, with no trickle vents, with locking handles and keys were available. Two of the kitchen windows are single glazed, painted timber type all of which appear to be in satisfactory condition.

Routine maintenance is advised to keep the windows functioning adequately. Hinges and locking mechanisms will need to be regularly lubricated in order to prolong their lifespan and efficacy.

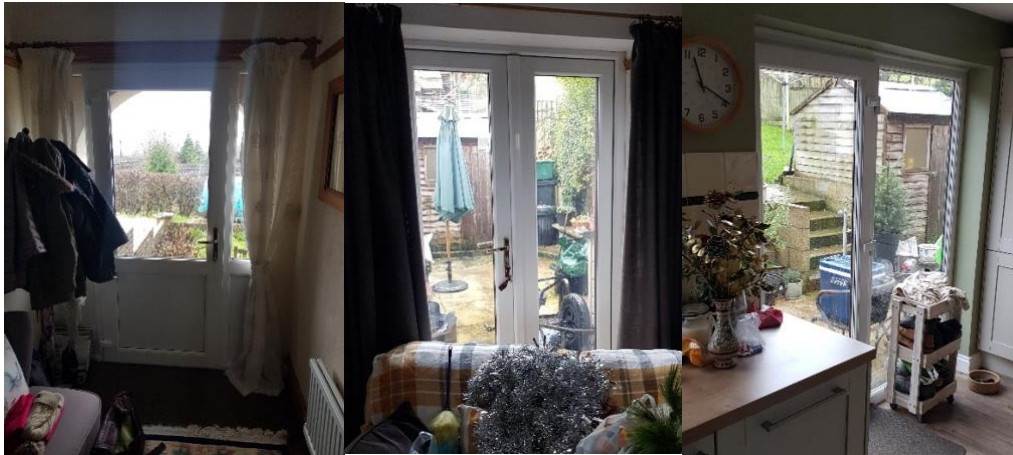
The entrance door, double doors from reception room and double doors from kitchen to garden are finished in brown externally, white internally and are of uPVC.

All doors in satisfactory condition, however, general care and maintenance will be required in order to prolong the life span and functionality of the doors.

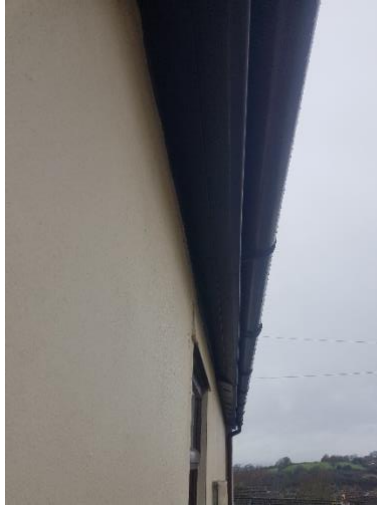
Soffits and fascias are constructed of uPVC type. These need general maintenance as necessary in order to preserve their lifespan.

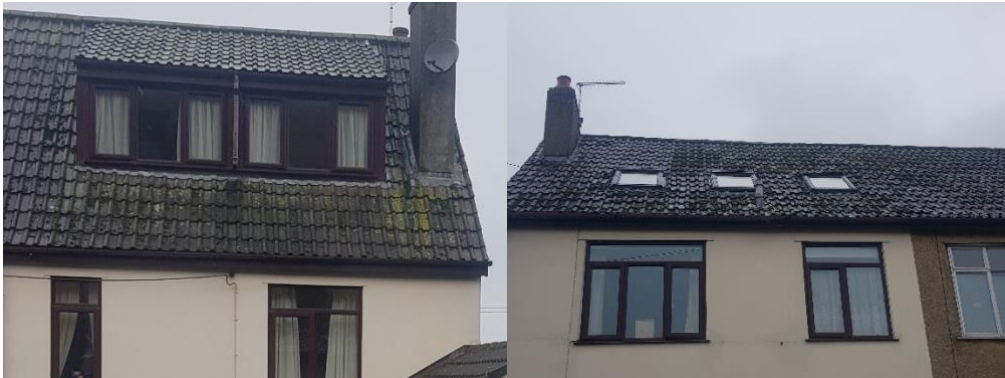
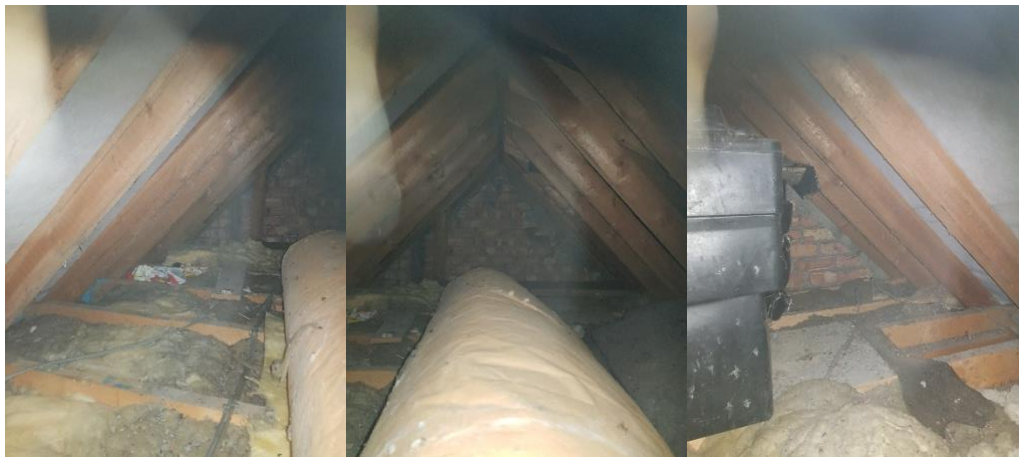
The original roof is pitched and ridged, clad with concrete tiles. To the rear, it has in the main, been replaced by a Dormer extension with a pitched roof also with concrete tiles. The front of the roof has also been utilised for living space and has Velux windows which appeared to be in satisfactory condition.

Although the roof space has mostly been utilised for living space access to the remaining roof space was via a loft hatch to the landing. The roof structure is of cut timber construction. Timbers, where visible, are adequately sized and appear to be suitably arranged with no signs of any significant twisting, distortion or deflection noted and there was no evidence of any water ingress. The underfelt is a breathable membrane, and this was seen to be in a satisfactory condition with no rips or tears noted. The party wall sits neatly to the rooflines and forms an adequate fire break.

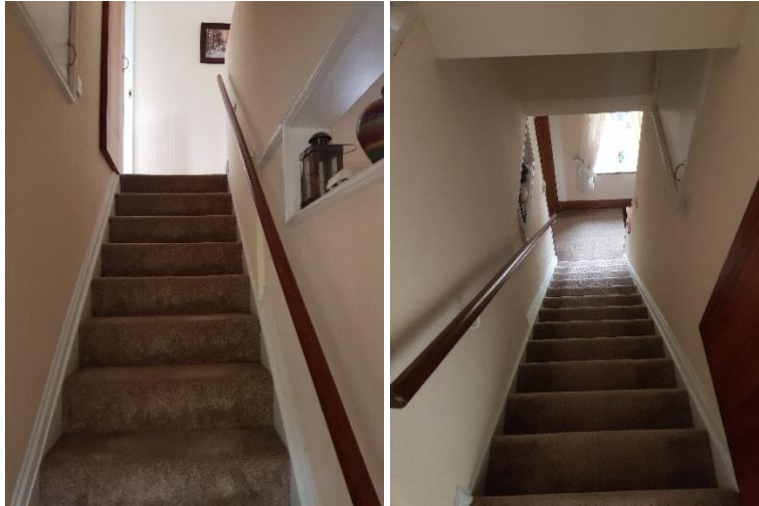
Access to the space is via an open staircase, the ceilings are of painted plasterboard, and there do not appear to be any hard-wired smoke detection. The loft space of this property was converted into living space in 1986 and may not have been subject to building regulation consent (generally required to convert loft or attic into a 'liveable space') as completion certificates were generally not introduced until the late 1980's. Requirements such as hard wired smoke detectors, protected stairway and fire rated - self closing fire doors were typically specified.

We recommend that you request any records such as drawings, receipts, building control approval or planning consent approvals relating to the loft conversion and ground floor extension from the vendors via your Legal Advisors. **Subject to these being produced we would also recommend that you instruct a specialist approved loft/attic contractor to ensure by making any necessary improvements, that the loft space complies with current fire regulations.**

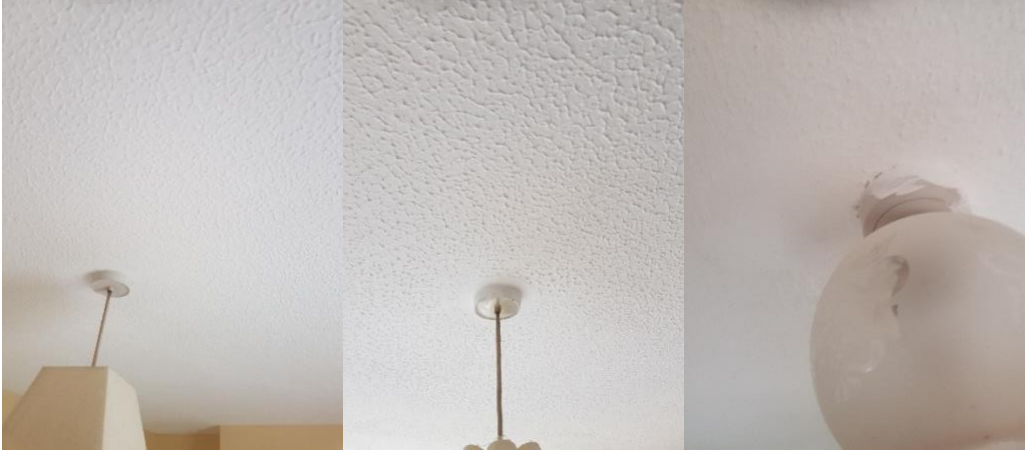
However, there are textured/Artex ceilings to the bedrooms and bathrooms of the upper floors which are likely to have asbestos content.

<p>This substance was banned from 1999 but was still used occasionally after this date and as the property precedes this date it could have been used.</p> <p>Asbestos is quite safe unless split or cracked when it becomes dangerous. It should not be tampered with in any way. If it is required to work on the ceiling – a specialist firm must be employed to carry this out.</p>

Possible asbestos was noted in the ceilings of the upper floors SEE F2.

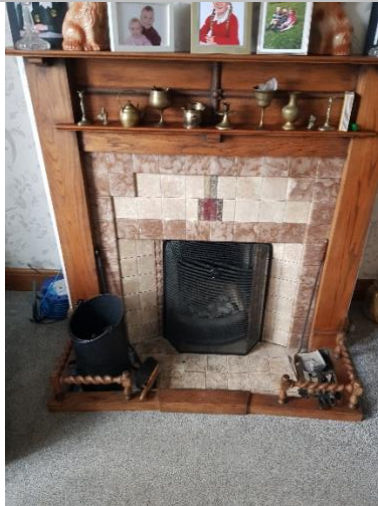
<p>There is a brick-built solid fuel fireplace with ceramic tiled hearth and timber surround in the main reception room. We recommend that a HETAS approved contractor is instructed to inspect and sweep the chimney on change of ownership.</p>	3
---	--

Building Regulations stipulate that all rooms containing open flue appliances are provided with adequate permanent external combustion air ventilation to ensure efficient discharge of poisonous flue gases and to reduce the risk of carbon monoxide poisoning. This was not seen, and the adequacy of ventilation must be confirmed. A carbon monoxide alarm should be installed and checked on a regular basis.

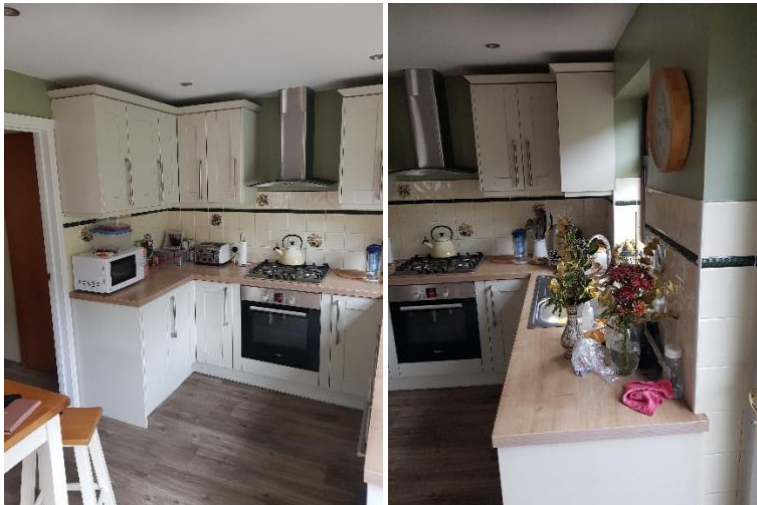
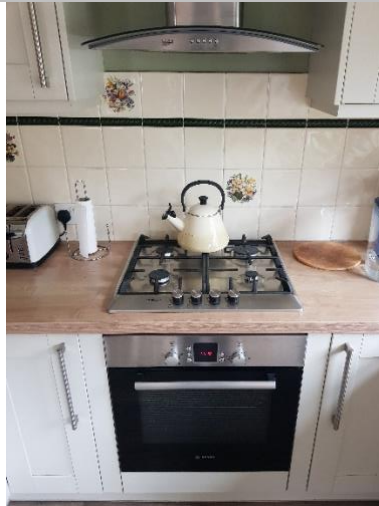
Kitchen units fitted are of a traditional type and are in reasonable condition, with a laminate worktops. Storage space in the kitchen is adequate with various cupboards and drawers, all in reasonable condition.

Gas hob should be tested on change of ownership.

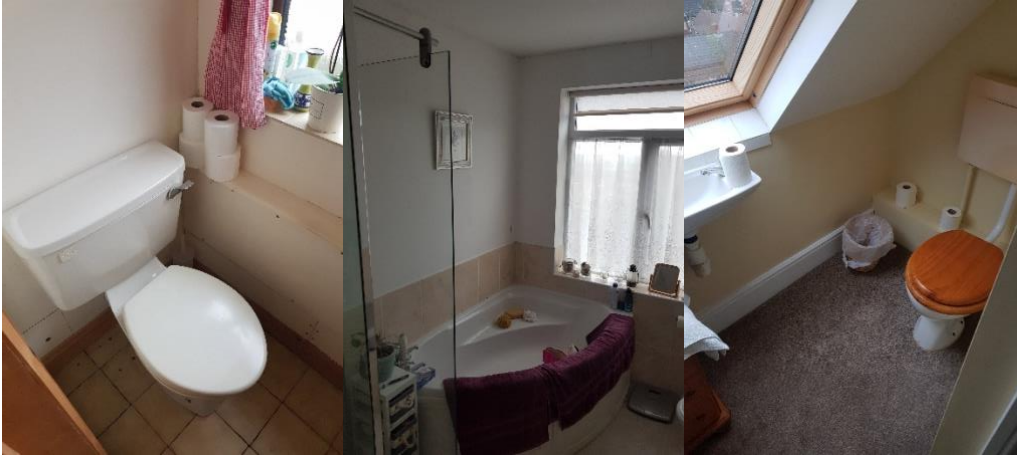
Tiling where fitted, to the bathrooms is of a ceramic type and appears to be in reasonable condition. The bath, showers, w.c.s and handbasins are all in a reasonable condition. The water pressure was checked to several draw-off points and found to be adequate. Water pressure can vary seasonally and during times of demand, both within the property and in the locality.

There were no extractor fans fitted to the bathrooms. Extractor fans are important to be used when the bathroom is in use so that condensation and water vapour is removed. Excess build-up of condensation and water vapour can lead to dampness and mould. The extractor fan will help to stop this problem from occurring.

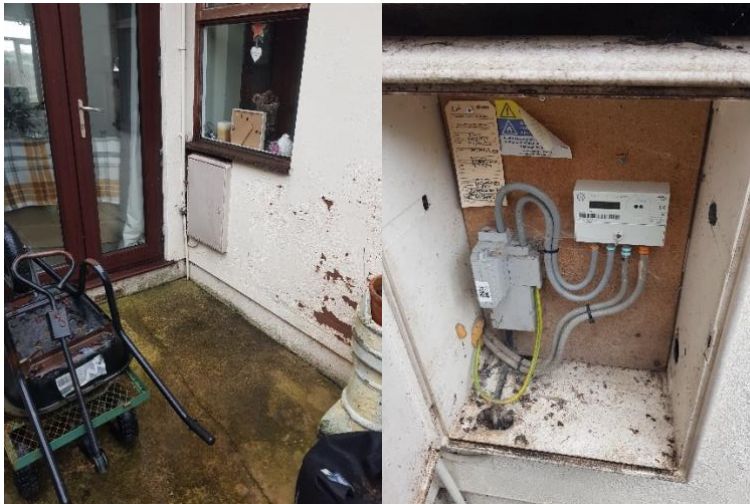
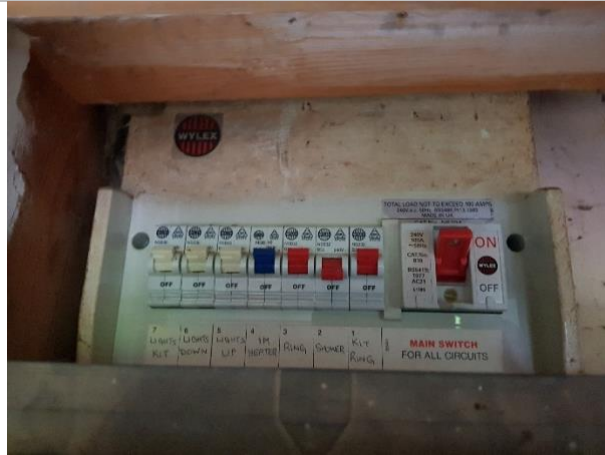
Mains electric with meter is located in a wall mounted cabinet on the rear kitchen wall and the consumer unit is located in a cupboard above the internal kitchen doorway.

The board is an older type with MCB's fuses.

It is strongly advised that an EICR (Electrical Inspection Condition Report) is obtained before exchange of contracts.

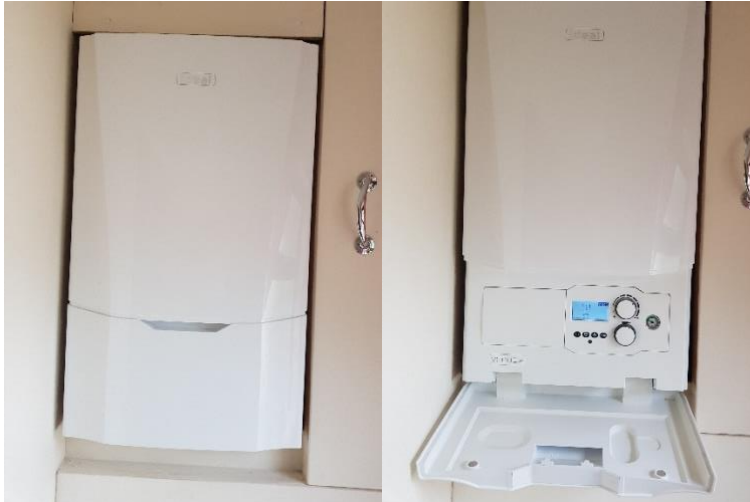
Age – Unknown

Service History – Unknown

Gas Safe Certificates should be seen. If not, the vendor must make them available to their Legal Advisor or failing that the vendor may have to service the boiler at their own expense.
