DUNFORD PENROSE
SURVEYORS

Level 2 Home Survey Report

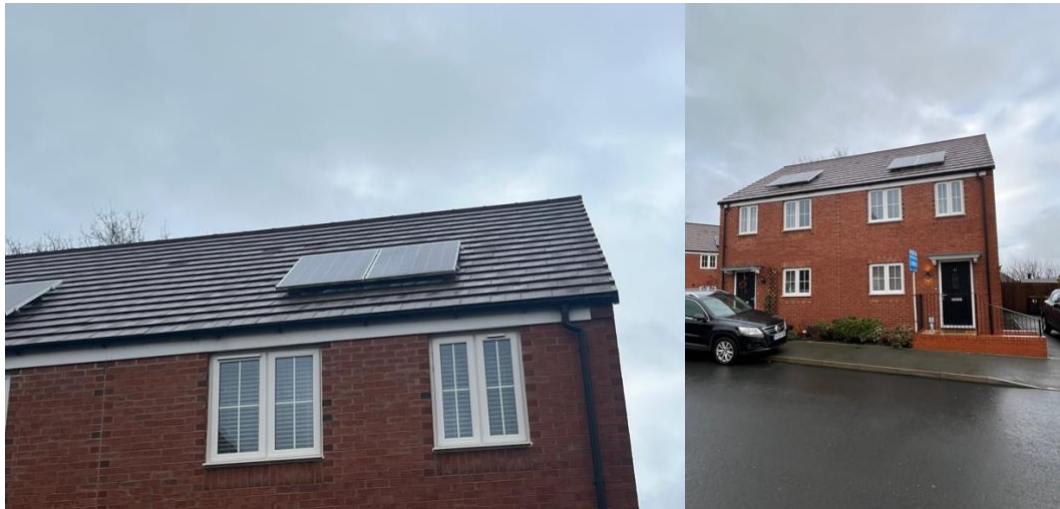
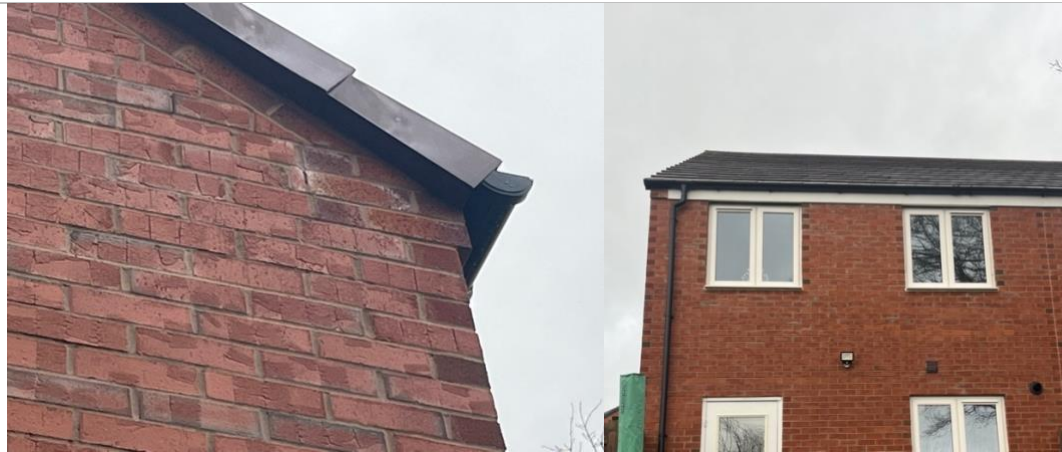
The roof is pitched and ridged and clad with concrete tiles, all in satisfactory condition.

The roofline appears to be level and within normal tolerances with no signs of any significant deflection or undulation noted, indicating that the roof structure is adequate for the current roof covering which seems in a satisfactory condition. There are “dry” verges were visible to the side elevation and were seen to be in a satisfactory condition. Dry verges are roofing elements designed to finish and seal the edges of a roof where it meets the gable end, providing a weatherproof barrier without the use of mortar.

Weather detailing is of lead type and was seen to be in a satisfactory condition with no tears or splits noted.

The roof was seen to be in an adequate condition at the time of the inspection. The roof covering will deteriorate over time, either in part or in full, depending on how long you own the property, and you should budget accordingly for this work.

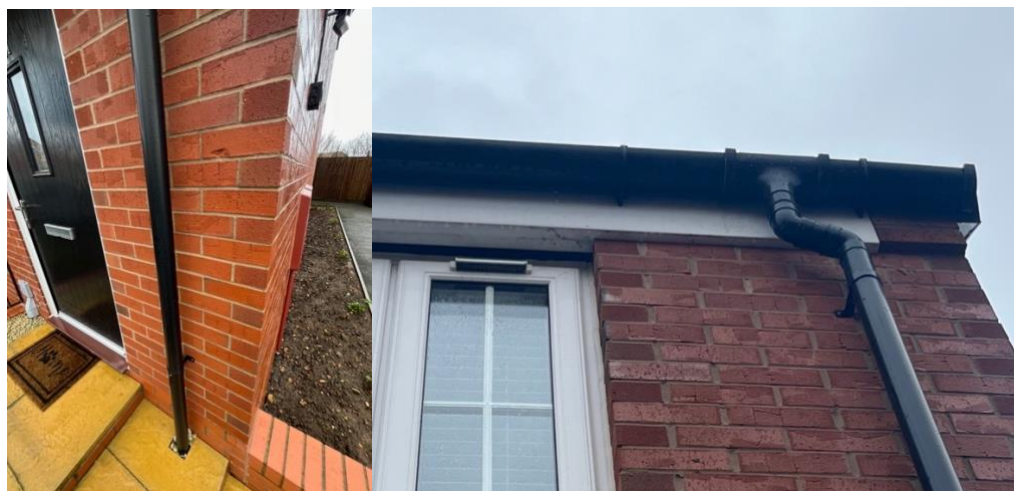
E3 Rainwater pipes and gutters

Guttering and downpipes are of a plastic type and are shared with the neighbouring property. The pipes are believed to discharge into a main drain, but this should be confirmed by your legal advisor during pre-contract enquiries. Rainwater goods appear to be adequately aligned with no signs of any significant twisting or distortion noted. A suitable number of support brackets appear to have been provided at regular intervals.

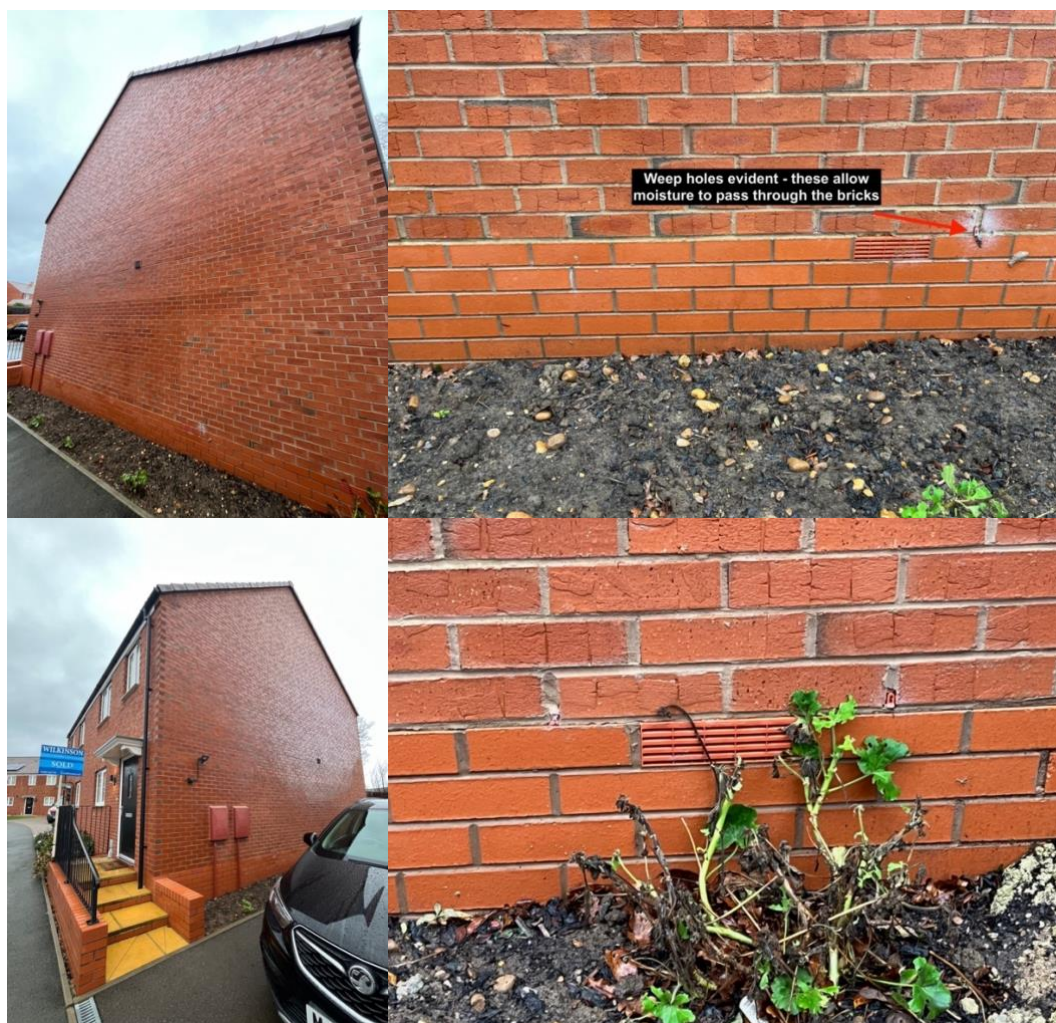
E4 Main walls

Weep holes were evident, these allow for the drainage of water; they are designed to let water escape from behind the wall, preventing moisture build up and potential damage.

Openings appear square to the eye with no signs of any significant movement or distortion noted. Normal repair and redecoration required.

Walls and openings, where visible, appear satisfactory for a property of this age and type with no signs of any significant movement or distortion noted. The foundations have not been exposed. Whilst there is a risk of unseen defects, there are no above ground signs of defective foundations. The risk of movement can be reduced by both maintaining the drainage in good condition and controlling the growth of trees, shrubs, and hedges.

The damp proof course is between 75mm and 210mm above ground level.

Lintels were visible on the ground floor only, but it is assumed that these are in satisfactory order as there were no signs of cracking or distortion. Not inspected.

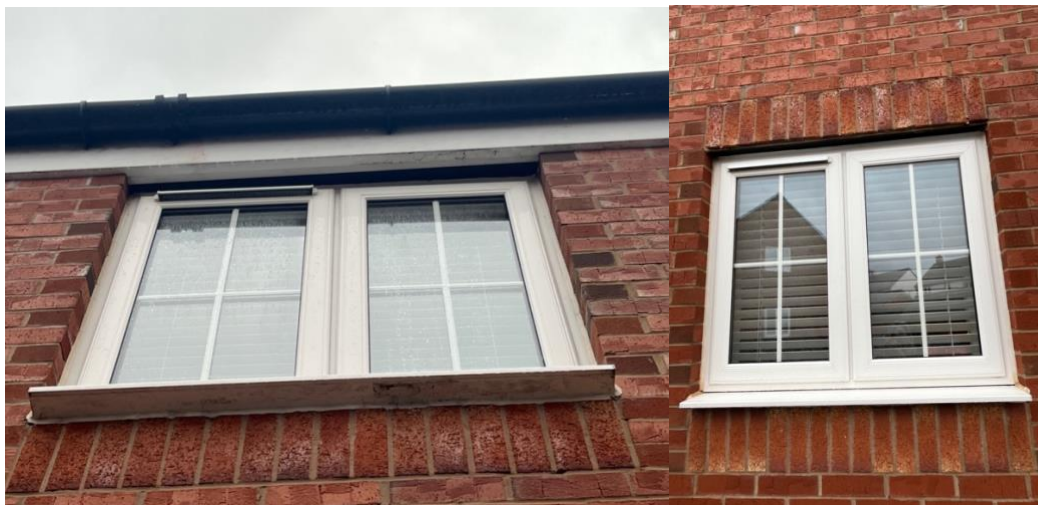
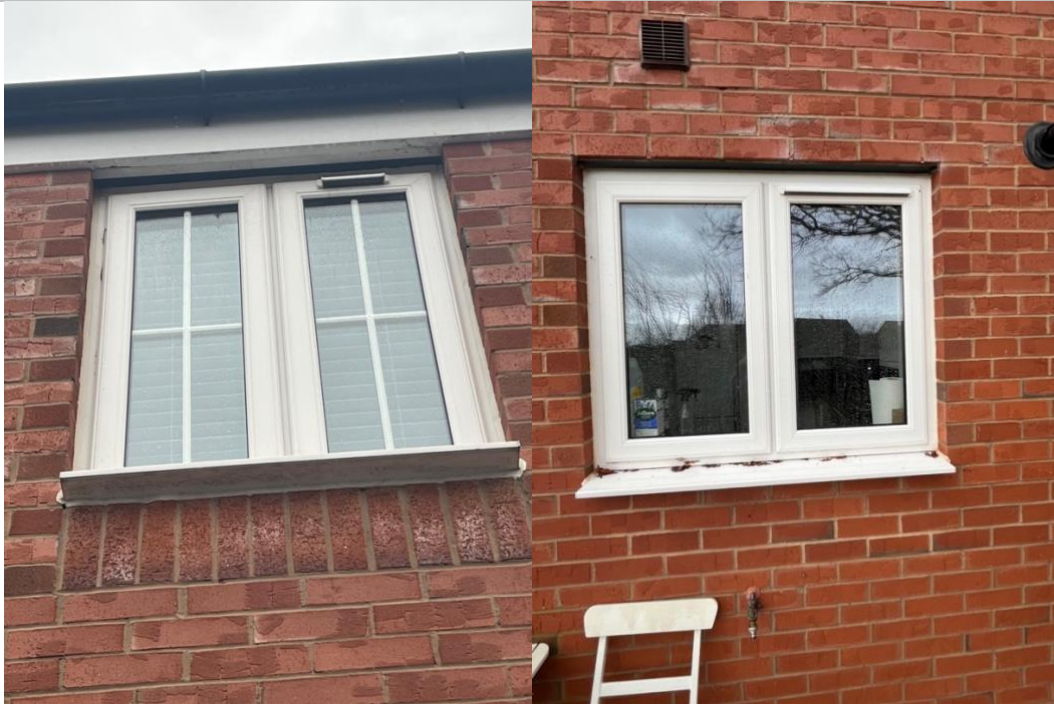
The windows are uPVC double glazed units with locking handles. Keys were available. Some windows have trickle vents fitted.

Window openings are square to the eye with no signs of any significant movement or distortion noted.

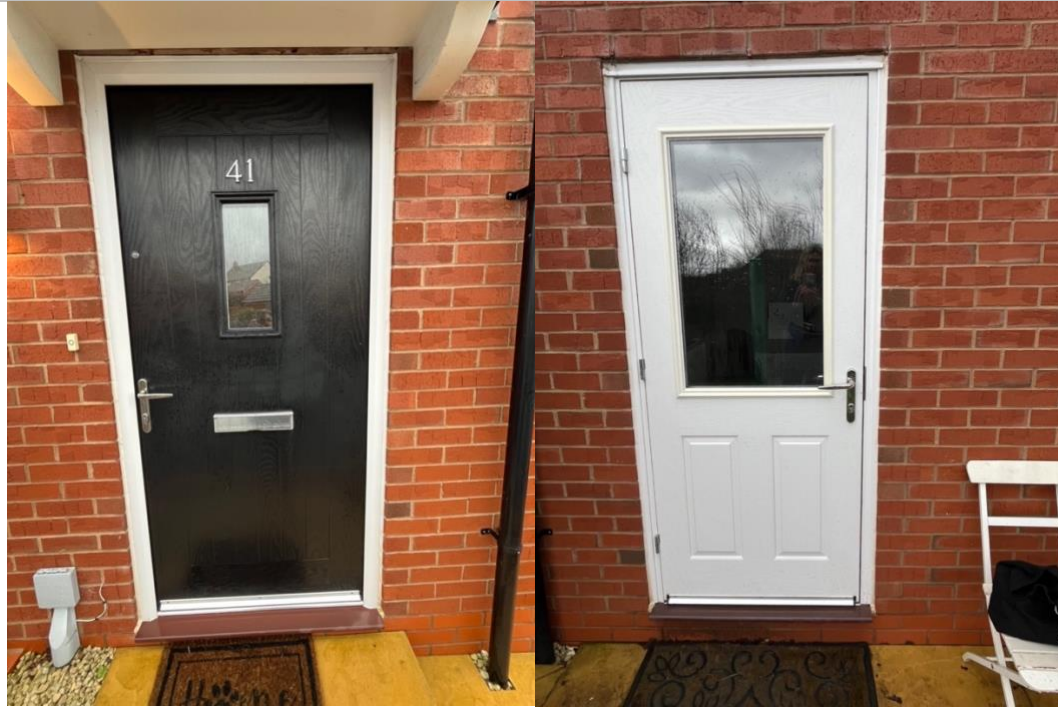
Both doors are in satisfactory condition; however, general care and maintenance will be required to prolong the life span and functionality of the doors.

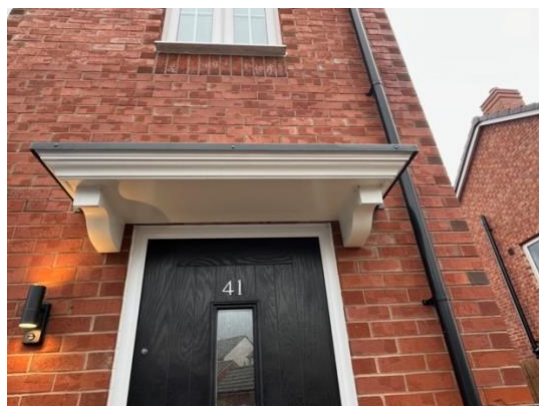
There is a storm canopy present over the front door, this is uPVC construction. Seen to be in satisfactory condition.

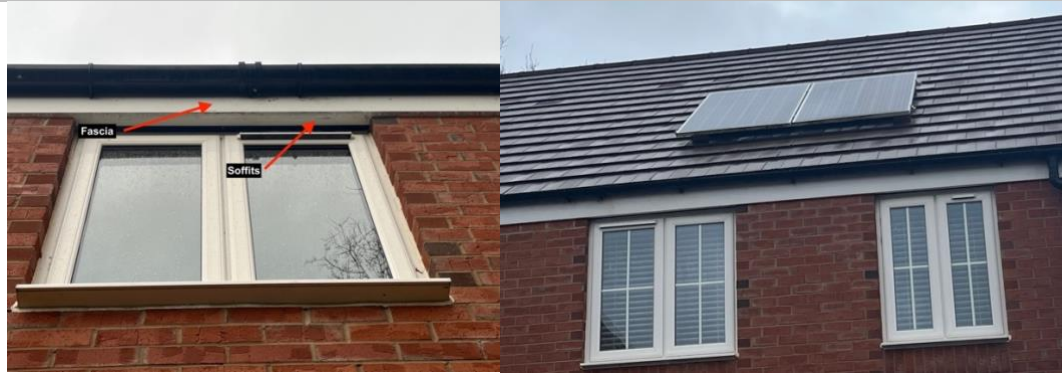
E8 Other joinery and finishes

The soffits and fascia fitted to the exterior roof line are of uPVC and appear in reasonable condition. General maintenance is necessary to preserve their lifespan.

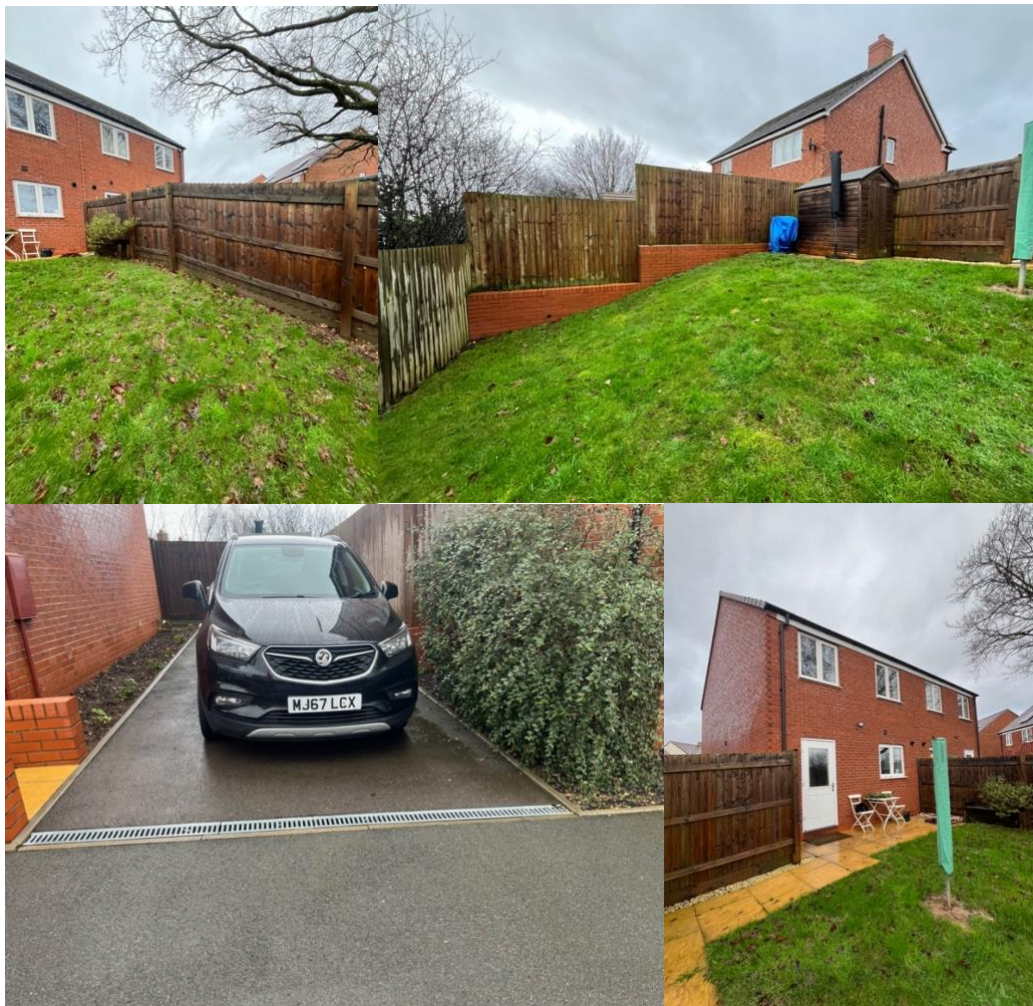
The proximity of the tree in the next-door garden is not of concern as it is more than twenty feet away. Trees should be more than twenty feet from a property due to possible damage to drainage systems and foundations, as well as falling branches.

The fences are of timber and are in satisfactory condition.

The tarmac driveway and stone slab patio are also in satisfactory condition.

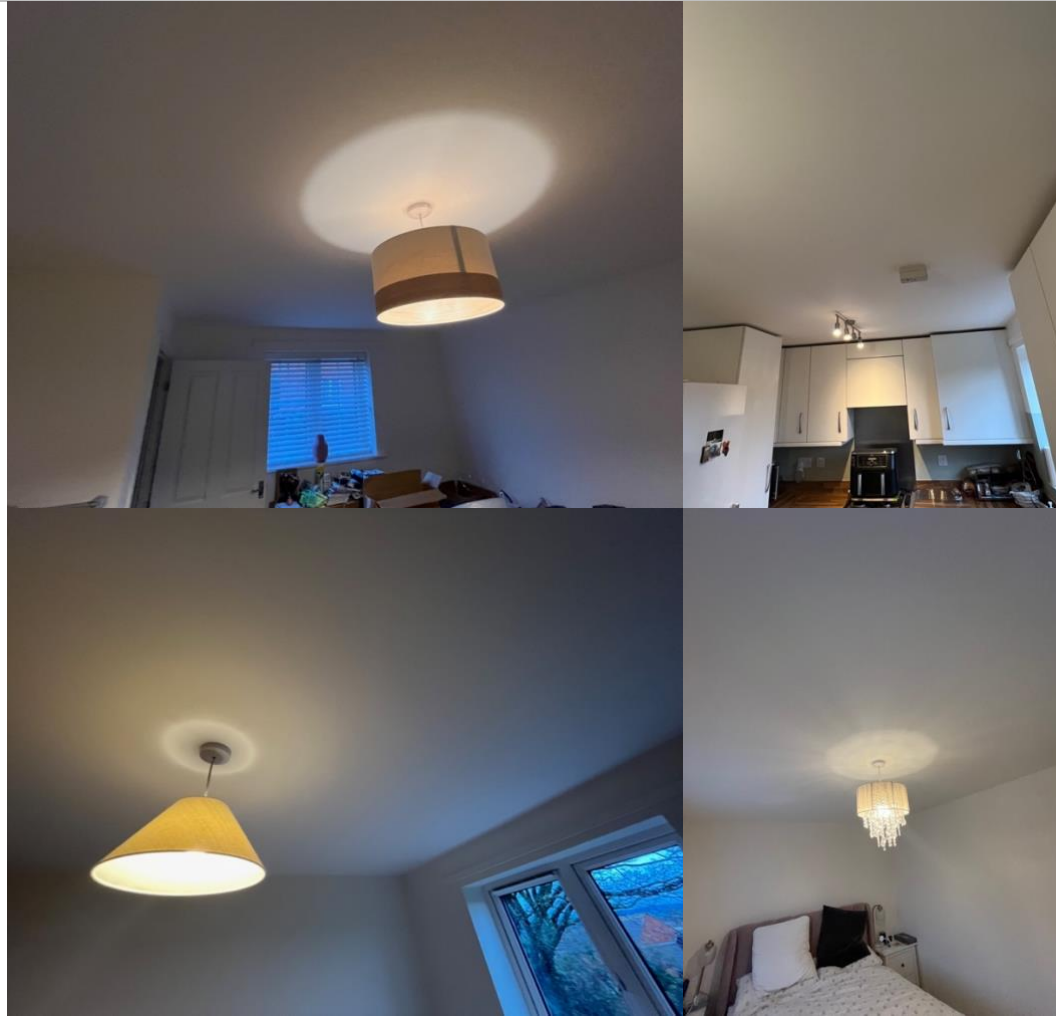
F2 Ceilings

Ceilings to the rooms have a plasterboard / papered / painted finish. All ceilings are in a satisfactory condition. Normal maintenance and redecoration must be undertaken as desired.

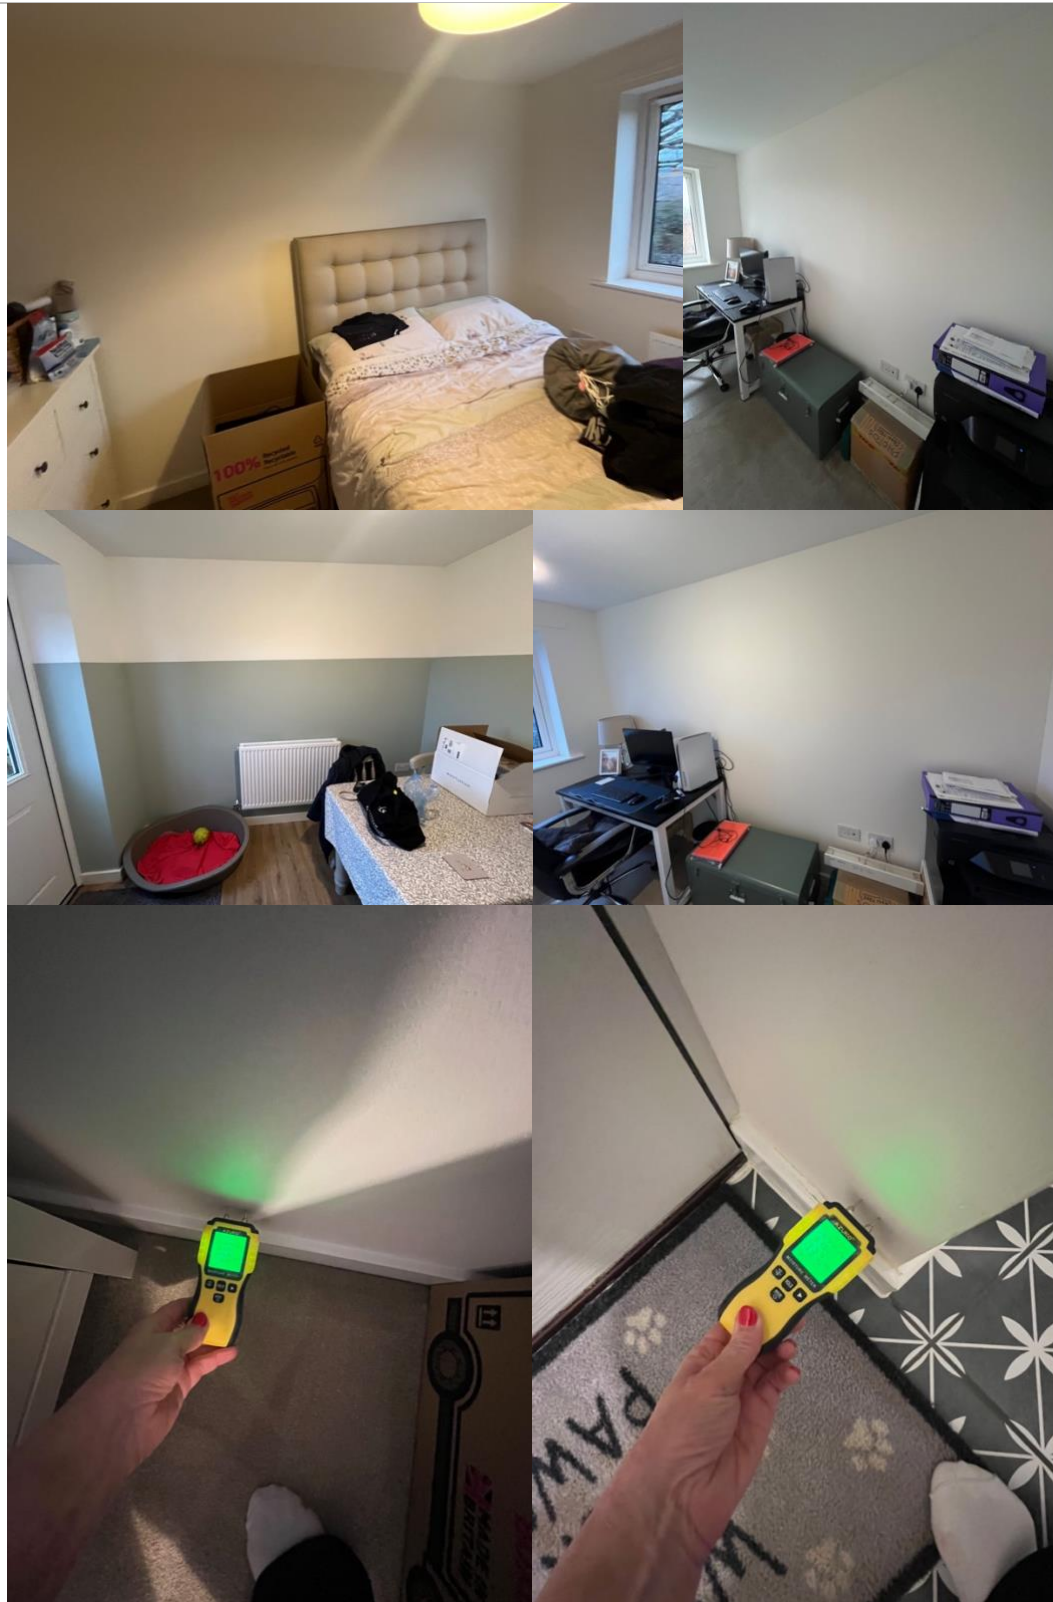
F3 Walls and partitions

The internal faces of the outside walls are finished in cavity masonry construction with plaster, board, and paint. Upon removal of existing decorative surfaces there is a possibility that areas of replastering will be necessary prior to redecorating. It is difficult to confirm the extent of redecoration needed when wall coverings are present, and plaster often requires replacement as finishes are stripped away.

Moisture content readings were taken throughout all the walls, with an electronic damp meter and no dampness was recorded.

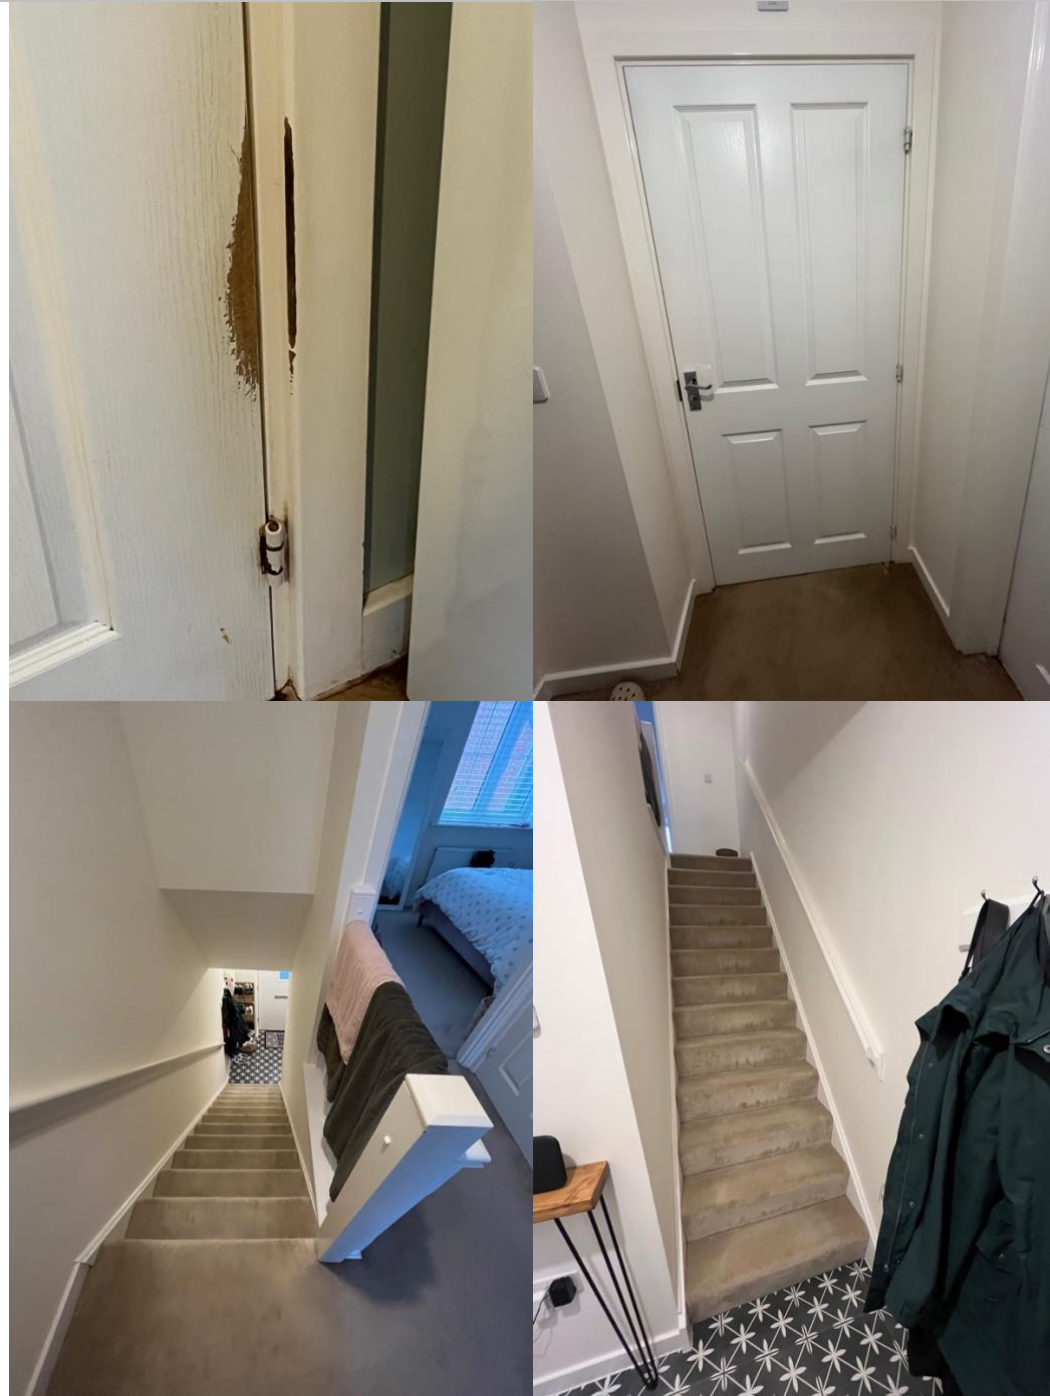
F7 Woodwork (for example, staircase and joinery)

All doors are of timber panelled type and are in satisfactory condition except for the kitchen door: the paint on the back of the kitchen door is damaged and needs redecoration. There was no twisting to the doors and all doors opened and closed correctly.

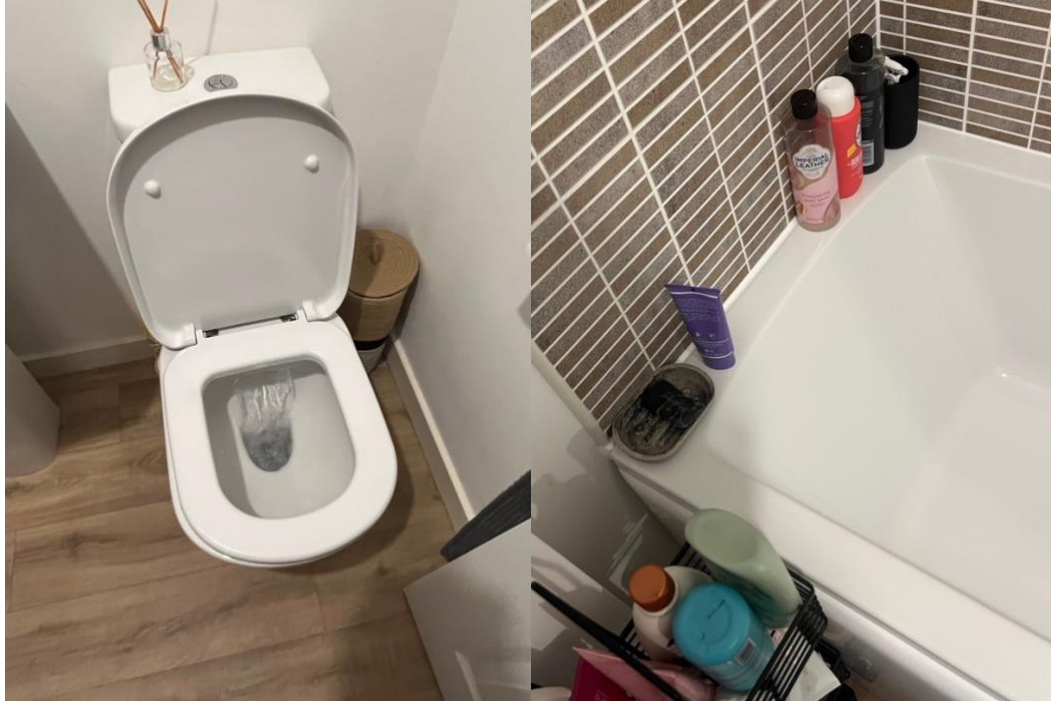
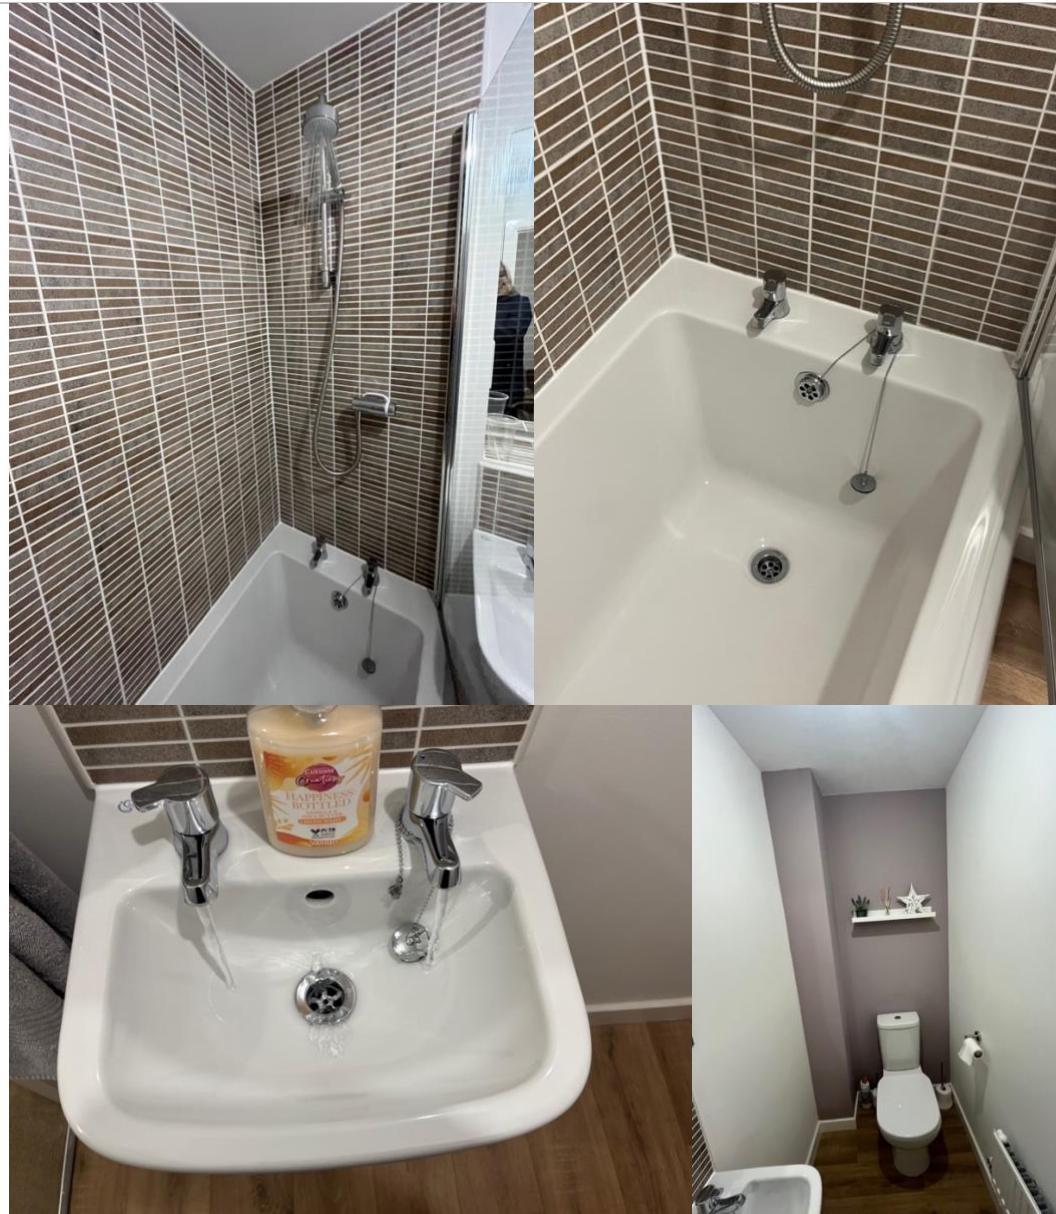
F8 Bathroom fittings

The tiling to the bathrooms is of a ceramic type and appears to be in reasonable condition. Although the bath, shower over, WCs and handbasins are all in a reasonable condition, general maintenance and cleaning will be required. The water pressure was checked at several draw-off points and found to be adequate. Water pressure can vary seasonally and during times of demand, both within the property and in the locality.

Most of the distribution and waste pipework is concealed beneath or behind sanitary ware items and whilst there were no obvious signs of leaks, the risk of hidden defects exists.

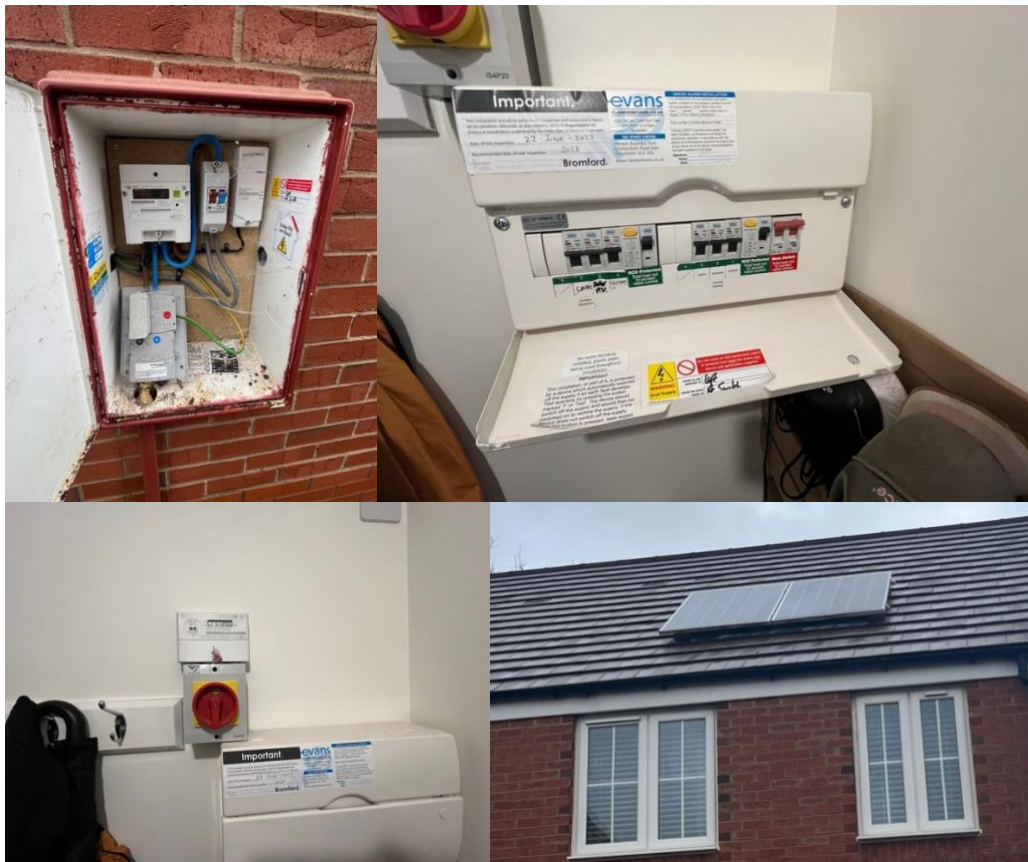
The property has solar panels fitted to the roof. Sunlight falls on the solar panels and generates DC electricity. That DC electricity is converted into household AC electricity by a Stag inverter. The AC electricity is fed into your electric meter and circuit breaker panel. It's advised that before purchase, the panels and inverter are checked by a qualified solar energy system inspector.

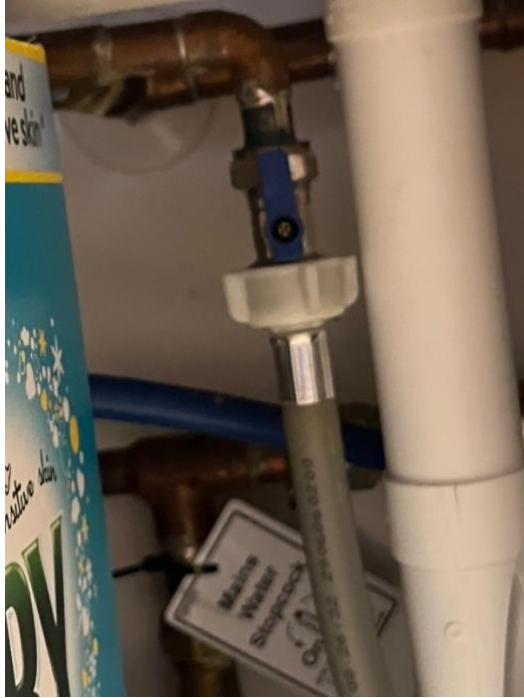
Cold water is supplied directly from the mains.

Most of the internal distribution pipework is concealed within the structure or behind fittings and whilst there were no obvious signs of significant leaks, the possibility of concealed defects exists.

The location of the internal stop tap is under the kitchen sink.

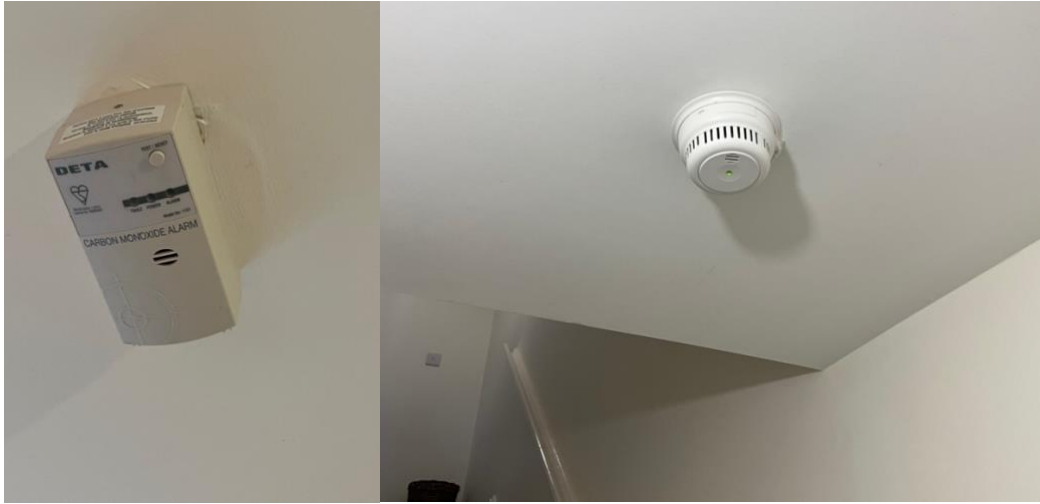
Whilst there are smoke detectors and carbon monoxide detectors fitted to the property, these have a limited life expectancy, and we therefore recommend that these are renewed at change of ownership as a life safety system.
