DUNFORD PENROSE
SURVEYORS

Level 3 Home Survey Report

EXAMPLE REPORT

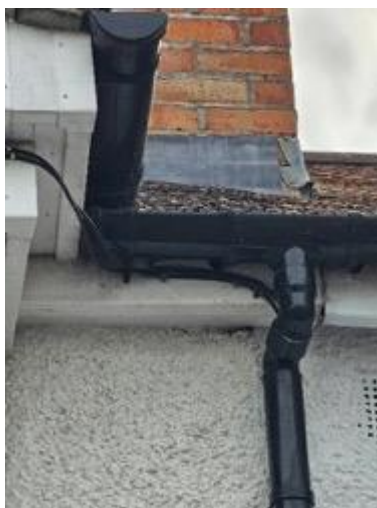
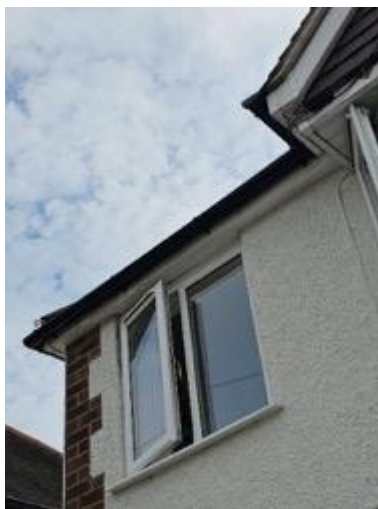
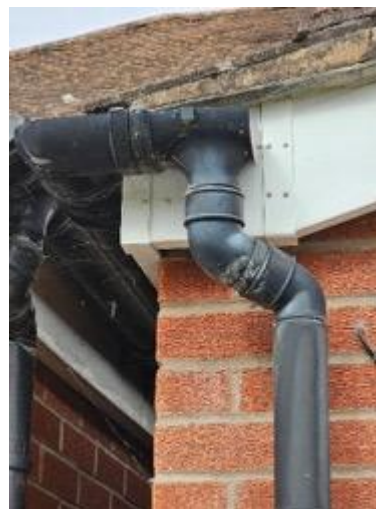
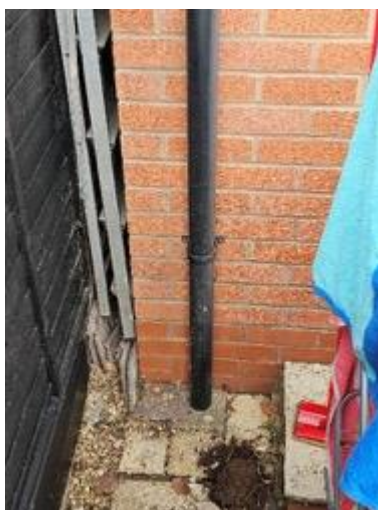
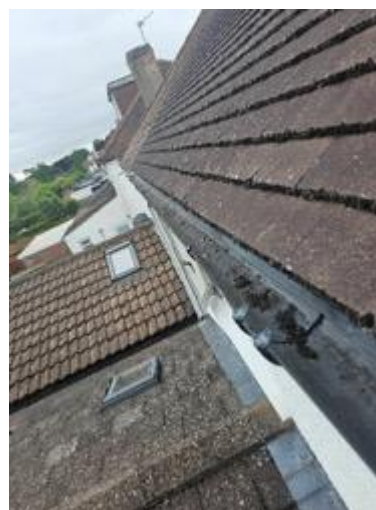
Rainwater goods discharge directly to ground. This is an unsatisfactory arrangement and they should look at diverting to the underground drainage system or install a water butt.

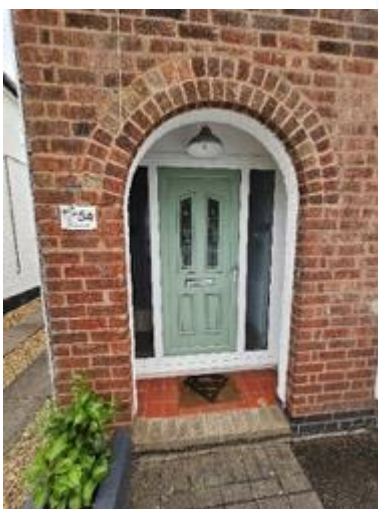
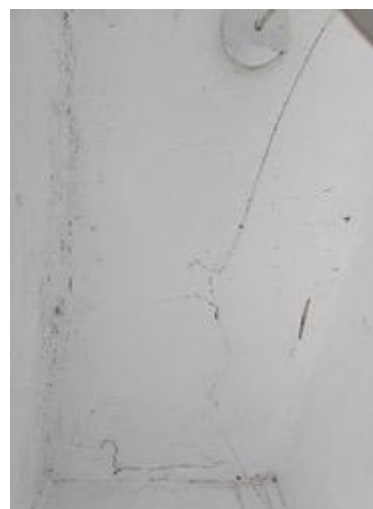
There is a recessed porch constructed within the external boundary of the property. The ceilings and walls are in satisfactory condition but require redecoration.

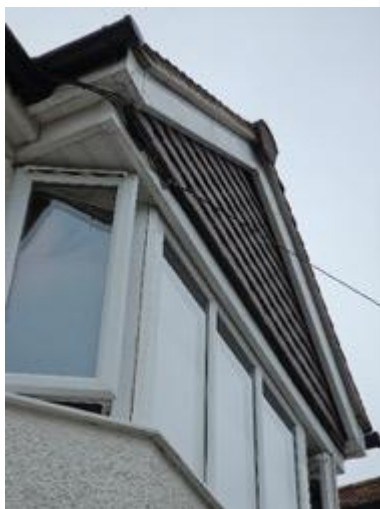
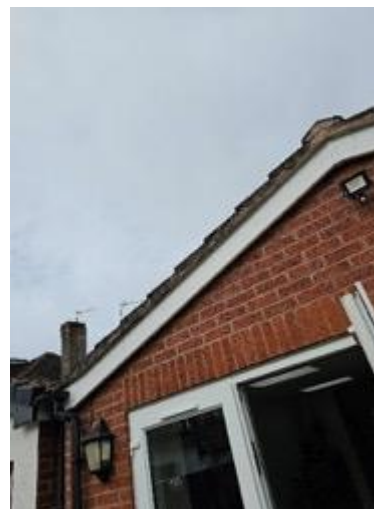
There have been examples in the past where original asbestos cement soffit boards have been left in situ, rather than correctly being removed by a professional contractor, during the upgrading or replacing of the previous installation. As we were unable to inspect behind the current coverings, there may be a possibility that these exist. If repair or replacement works are required to be carried out to the current coverings, then care should be taken until it can be confirmed no asbestos is present – SEE J1.

Soffits and fascias were seen to be in reasonable condition. however regular cleaning, inspection and general maintenance is necessary in order to preserve their lifespan.
