Level 3 Home Survey Report

2nd January 2023

DUNFORD PENROSE SURVEYORS

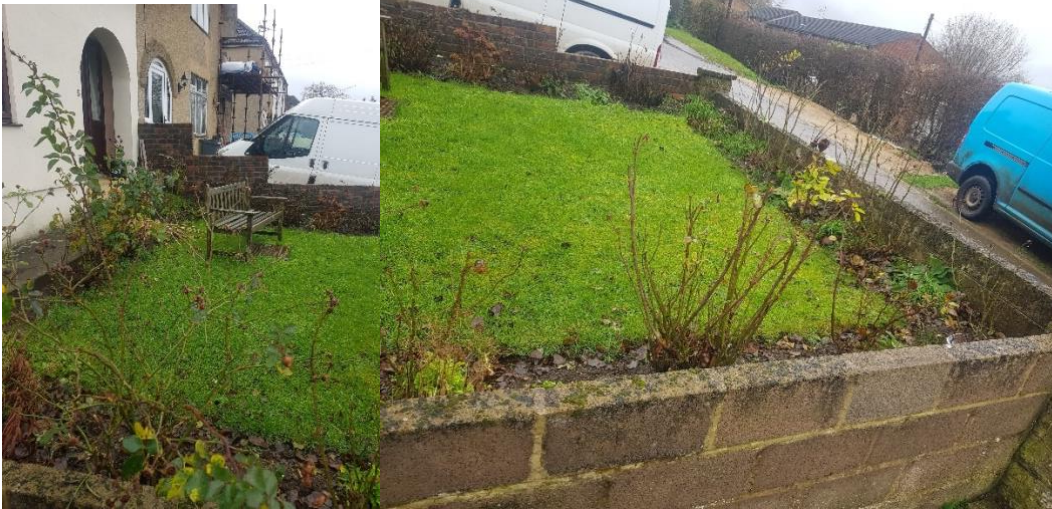
Mainly grass with flower borders and pathway leading from block paved driveway.

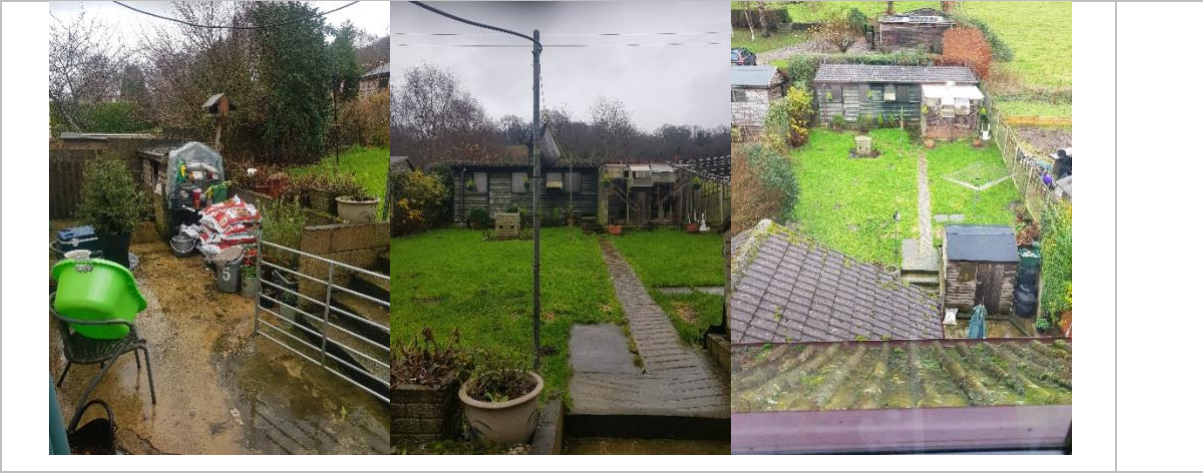
Rear Garden:

Concrete patio/yard adjacent to the house with a retaining wall and concrete steps leading to a large area of grass with footpath.

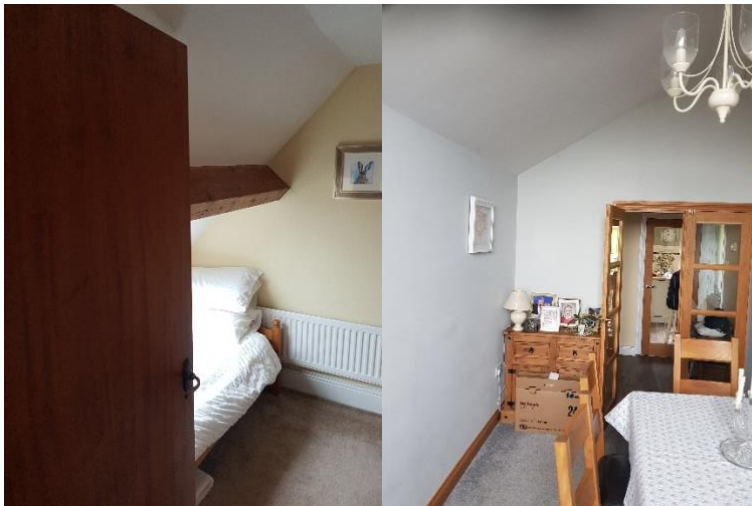
Doors to the ground floor are timber, two with glazed panels to the ground floor and timber to the upper floors and are in satisfactory condition. There was no twisting and all doors opened and closed correctly. Door openings appear square to the eye with no signs of any significant movement or distortion noted.

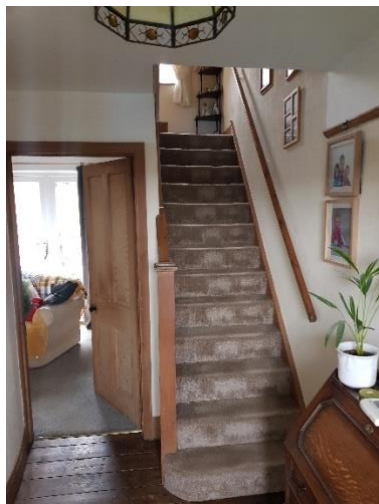
The windowsills, skirtings and architrave are of painted timber and are in a satisfactory condition. The staircase is of timber type with timber handrail, all seen to be in a satisfactory condition.

All timbers should be tested for woodworm, although we did not find present infestations, that is not to say previously there may have been some. SEE F1.

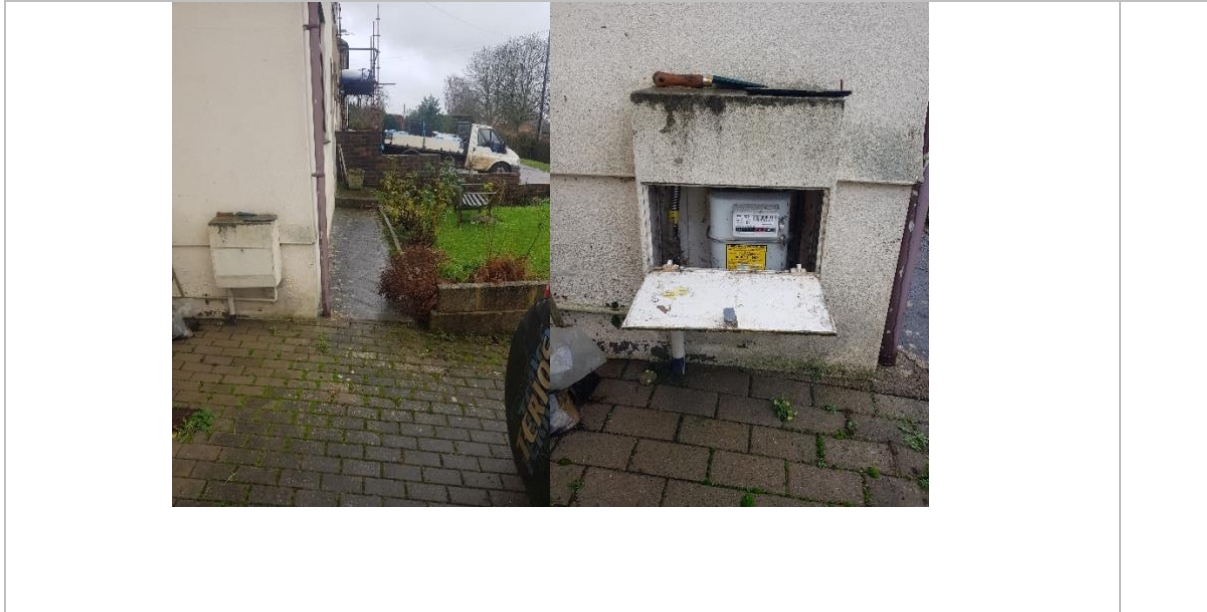
Gas is brought to the property by underground pipe to a meter located in a wall mounted cabinet to the side of the building.

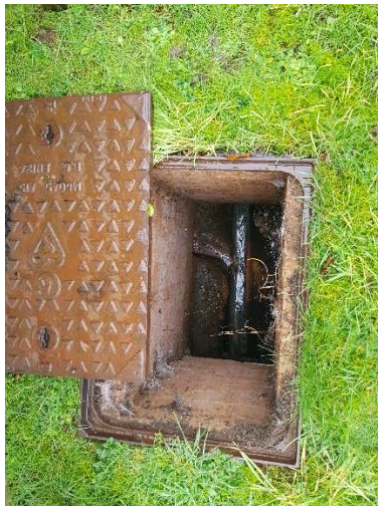
The property is connected to the mains drains. Sinks and wash hand basins drained promptly suggesting that there are no current blockages from the house. The inspection chamber, located in the front garden was inspected and found to be clear and free flowing.

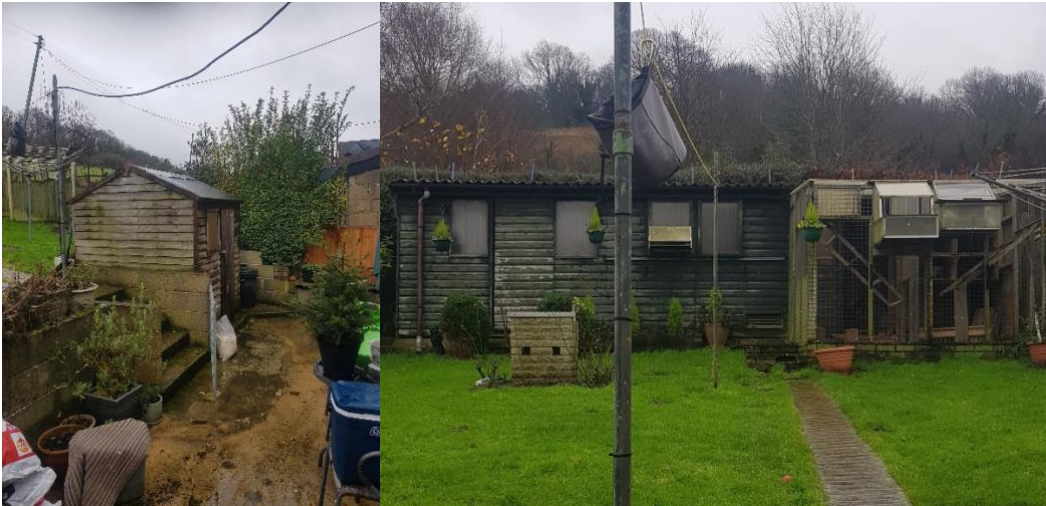
There are two timber structures in the rear garden. In the patio area, there is a standard timber garden shed with a felt roof, which appears to be in reasonable condition. At the rear of the garden there is a large painted timber construction with a tiled roof currently used to house pigeons which, other than some decoration, also appears to be in reasonable condition.

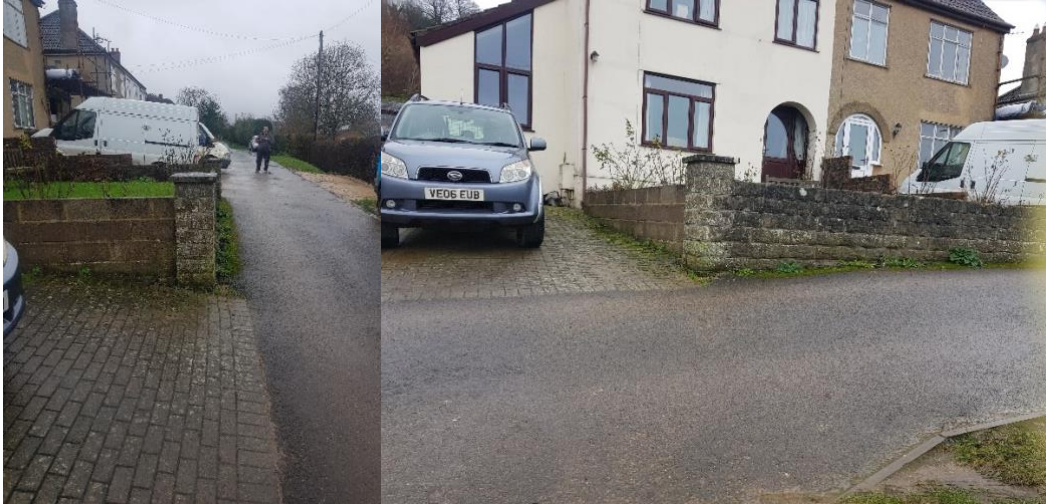
The front boundary is defined by a stone wall and the threshold between blockwork drive and public footpath.

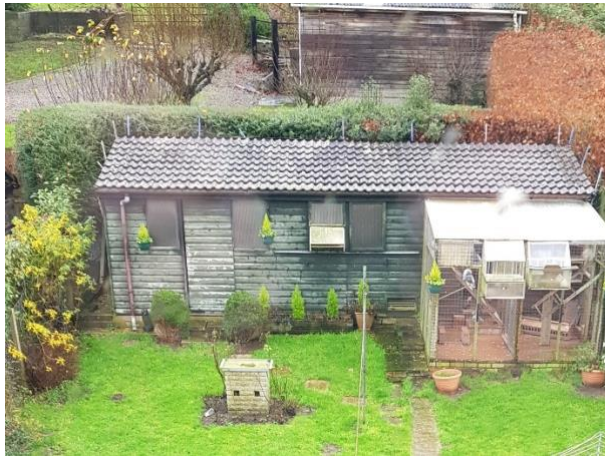
The rear boundary is defined by a large hedge and wire fencing behind the timber garden structure.

Your Legal Advisor should confirm all boundaries to you, including any rights of way and obligations for the maintenance of fences.

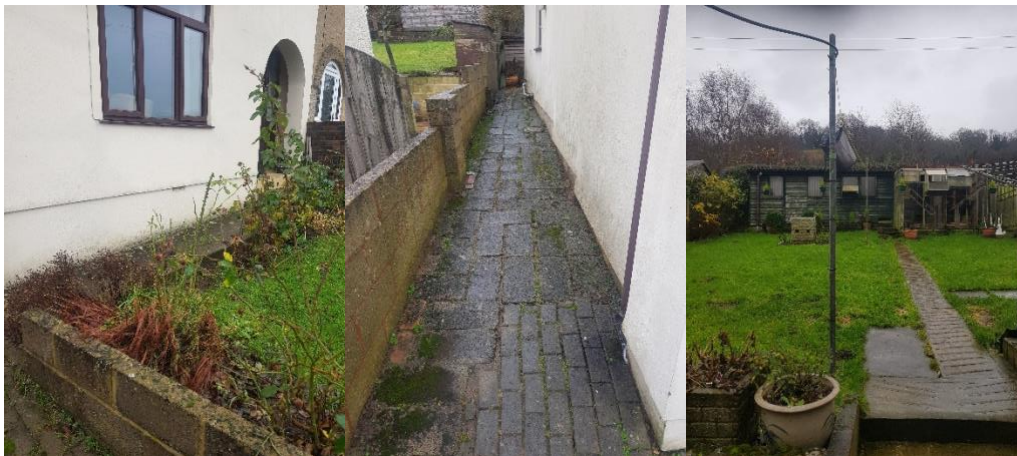
There is a small concrete pathway along the front of the property, stone pathway to the side and a concrete pathway running centrally in the rear garden. There is a concrete patio area adjacent to the building. All these pathways were seen to be in a satisfactory condition.

General on-going maintenance is required in order to maintain the useability and the life expectancy of the paths and patio.
