DUNFORD PENROSE
SURVEYORS

Level 2 Home Survey Report

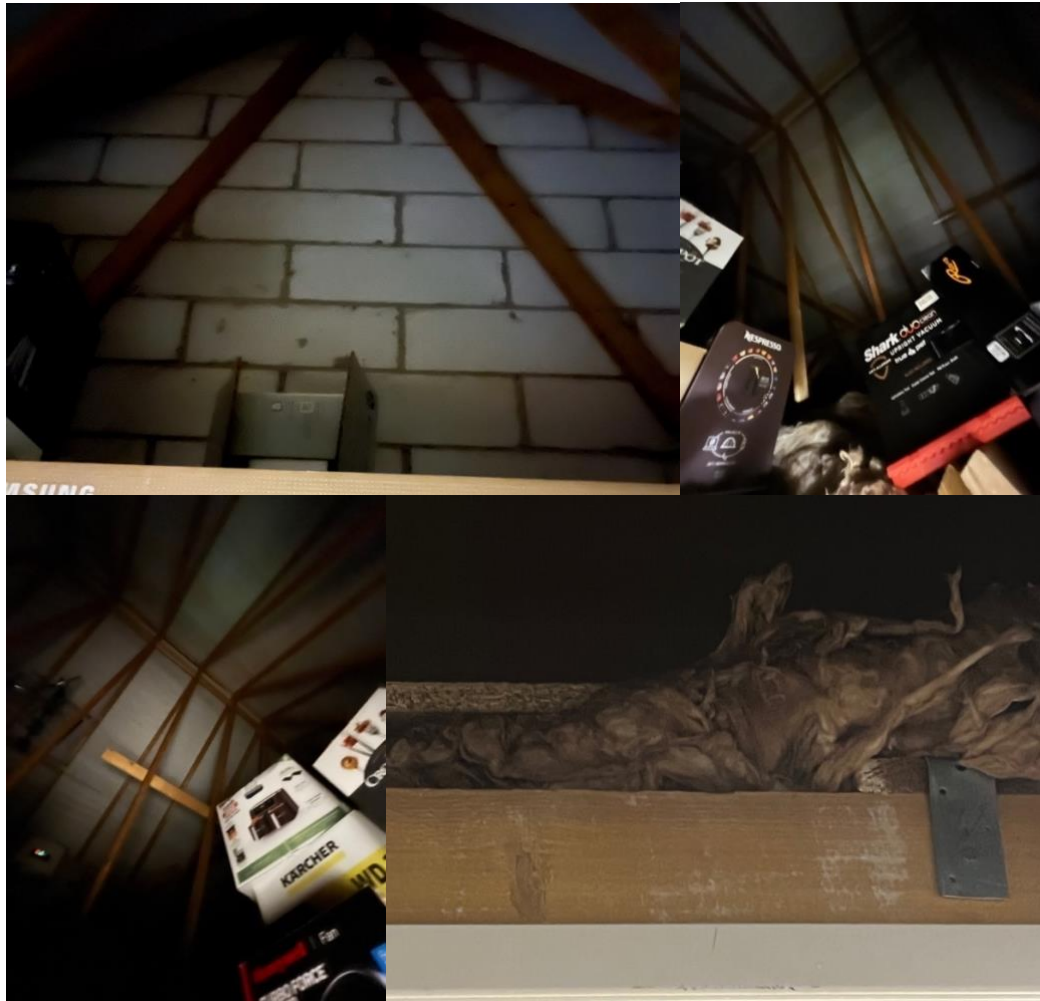
You should confirm with your legal advisor that there is a current woodworm treatment certificate, otherwise, we advise you to carry out a woodworm treatment.

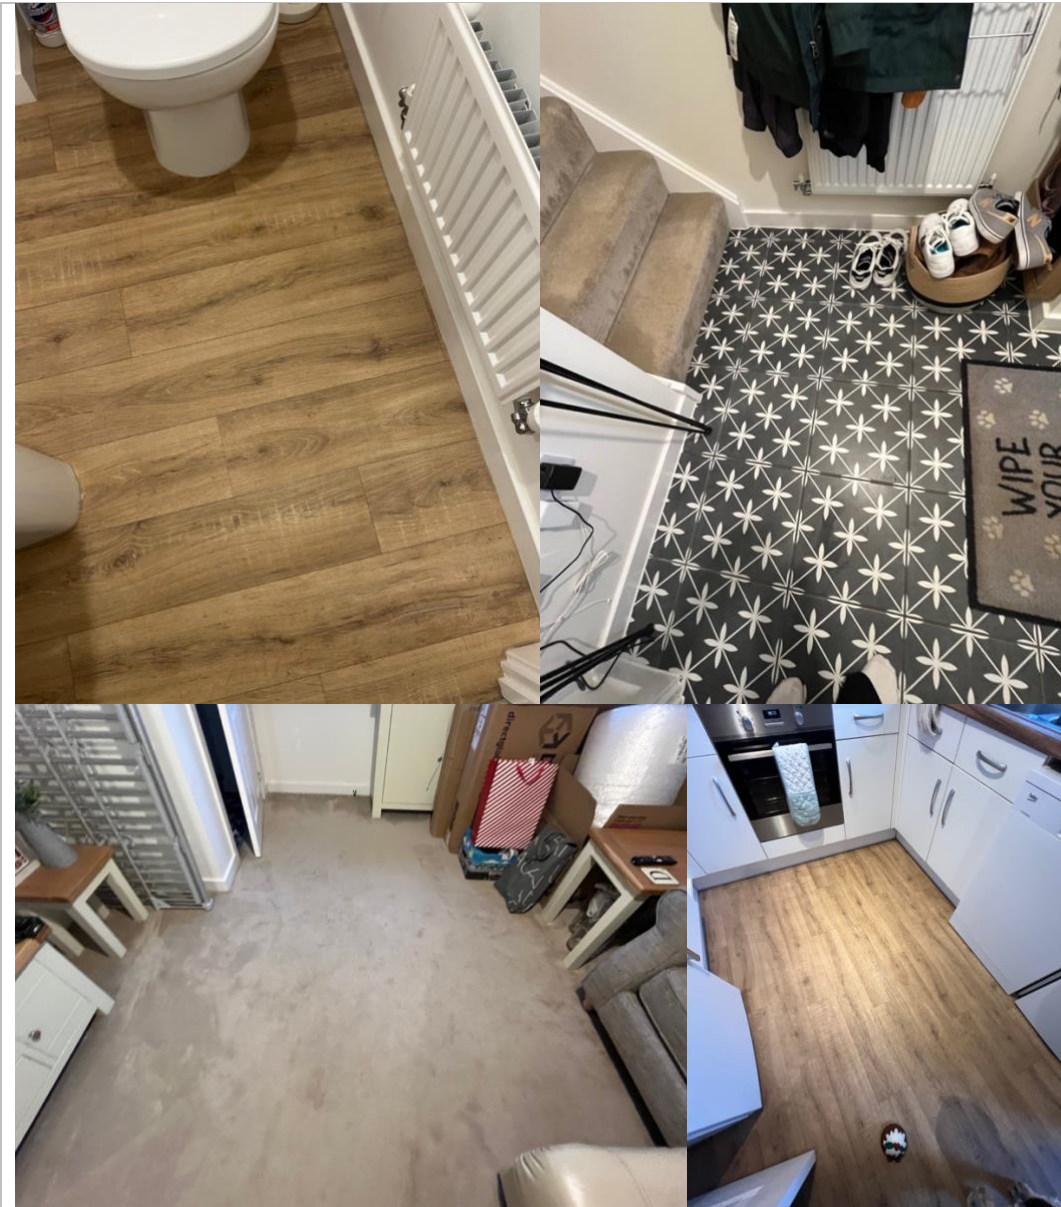
Fitted coverings where they are present, and furniture inevitably restricted the detail of inspection. The risk must be accepted that concealed defects may exist beneath the floor coverings.

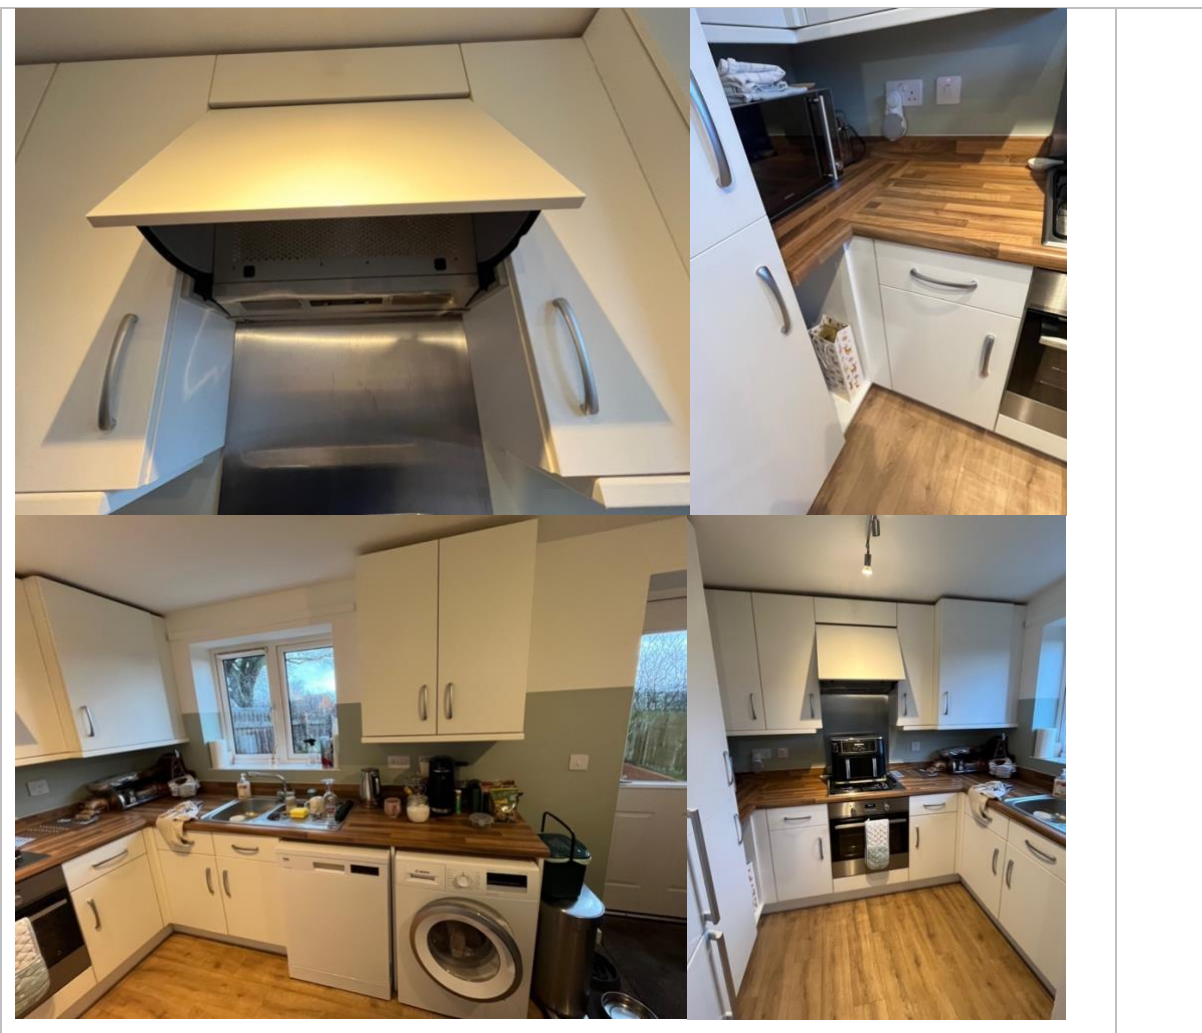
All doors are of timber panelled type and are in satisfactory condition except for the kitchen door: the paint on the back of the kitchen door is damaged and needs redecoration. There was no twisting to the doors and all doors opened and closed correctly.

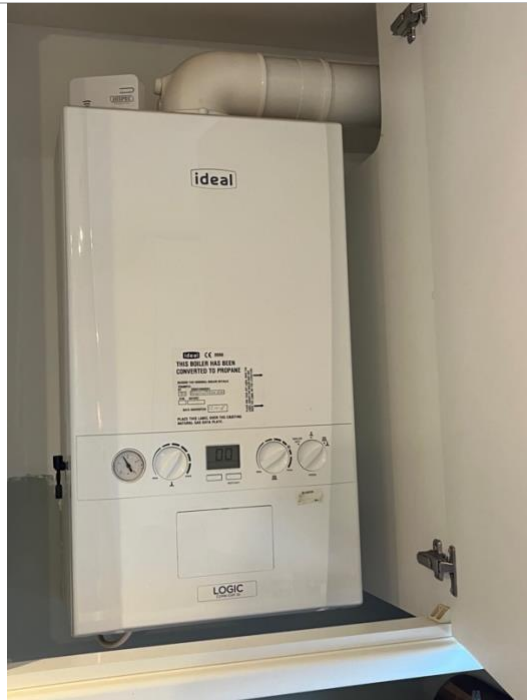
A Gas Safe inspection certificate will ensure that the appliance is running safely, however a boiler service involves checking the individual boiler parts to make sure they are clean and working efficiently and is safe; this is why the service record for the boiler should be obtained, certainly if it has not been serviced yearly by a Gas Safe engineer.

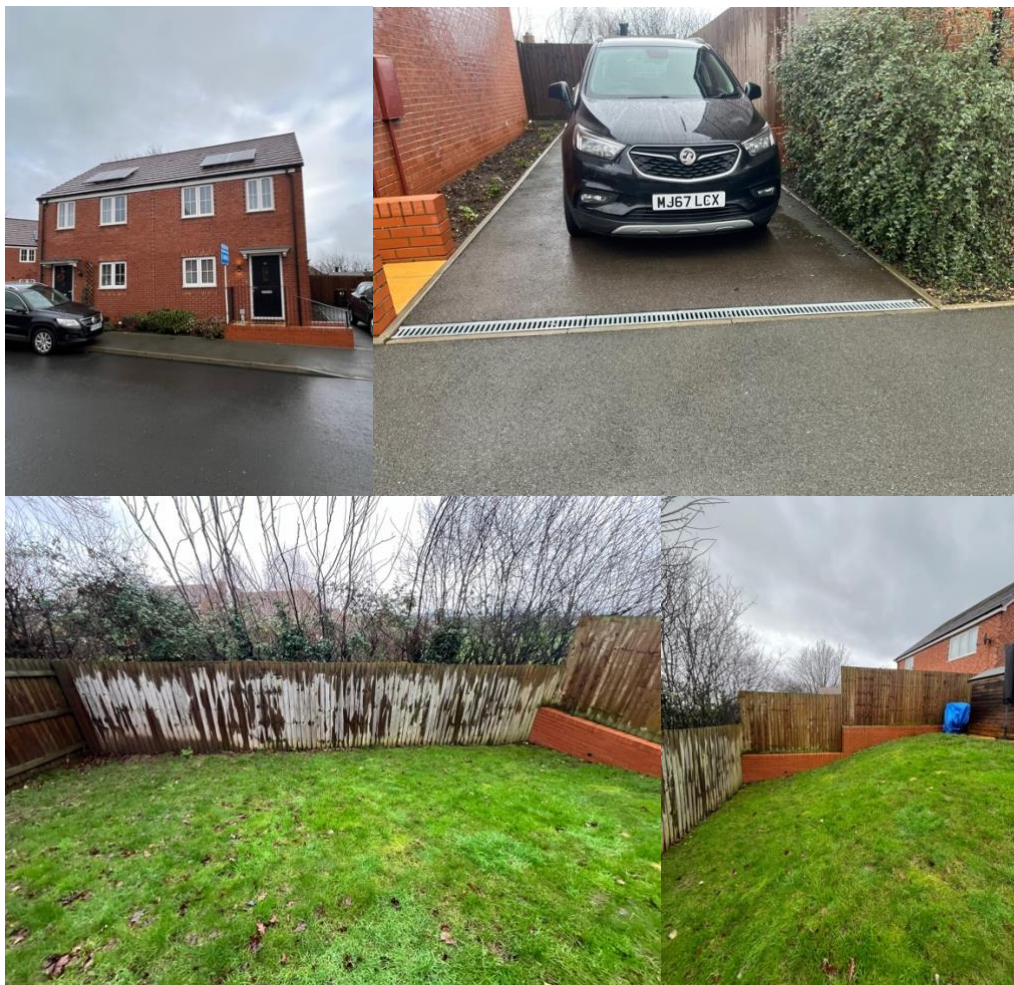
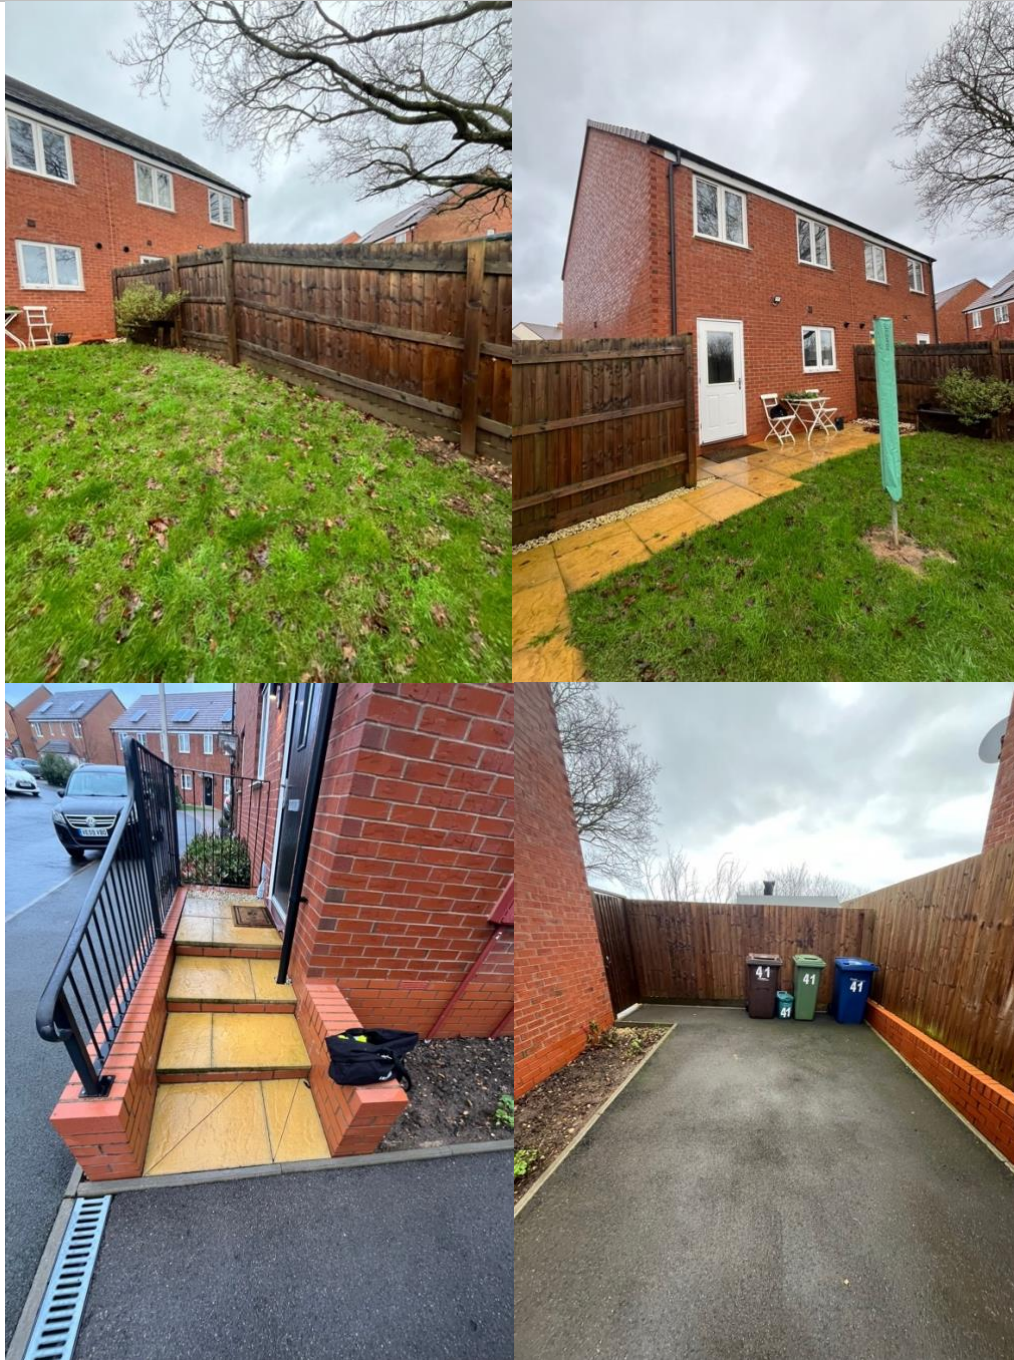
General on-going maintenance is required to maintain the useability and the life expectancy of the patio.
