DUNFORD PENROSE
SURVEYORS

Level 3 Home Survey Report

EXAMPLE REPORT

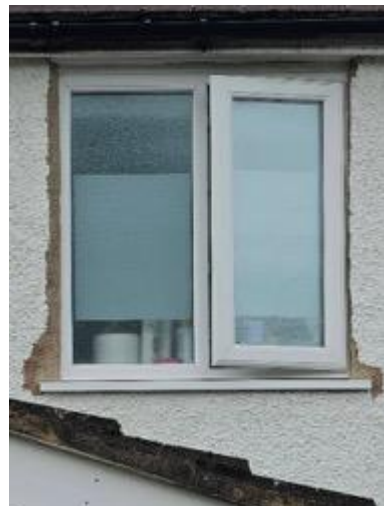
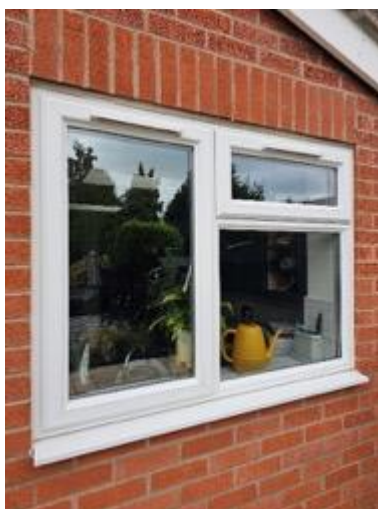
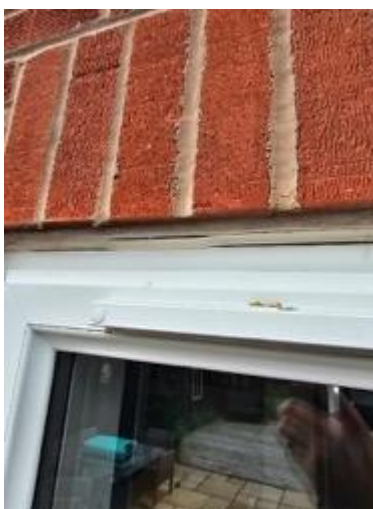
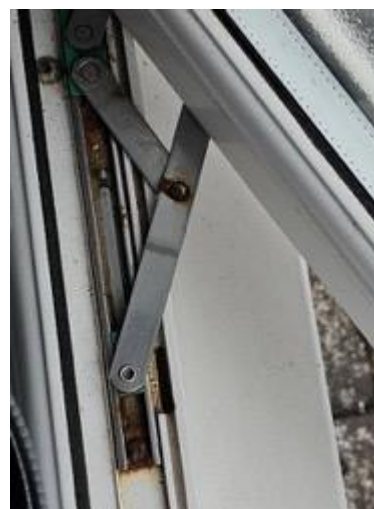
Condition Rating: 2

There was evidence of safety glazing having been provided. In the eventuality that replacement glazing will be required over a period of time, it should be ensured that safety glazing is installed.

Routine maintenance is advised to keep the doors functioning adequately and all hinges and locking mechanisms will need to be regularly lubricated in order to prolong their lifespan. We also recommend you change all locks upon occupation to enhance security.

Regular maintenance of mastic sealant is essential to preserve the appearance and functionality of areas prone to moisture. Semi-annual inspections and gentle cleaning are recommended to sustain the sealant's effectiveness. If signs of wear such as cracking, peeling, or the presence of mould are observed, it is crucial to address these issues promptly. Cleaning mould with an appropriate mould spray as soon as it appears and

reapplying a compatible sealant will ensure continued protection against moisture ingress and help maintain the property's overall aesthetic condition. This routine care prevents the development of more significant issues over time. It is advisable that all internal and external seals are checked to ensure no gaps are present as any minor perforations to these areas will allow wind driven rain and moisture to enter the property which can lead to dampness and the deterioration of the walls.

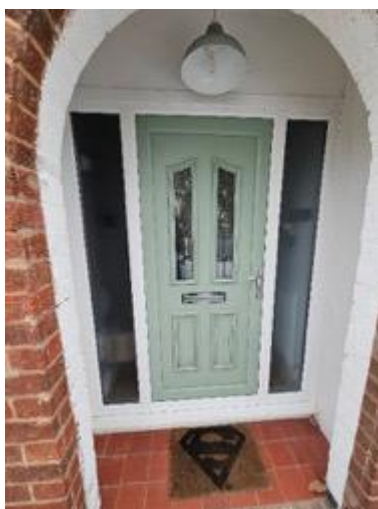
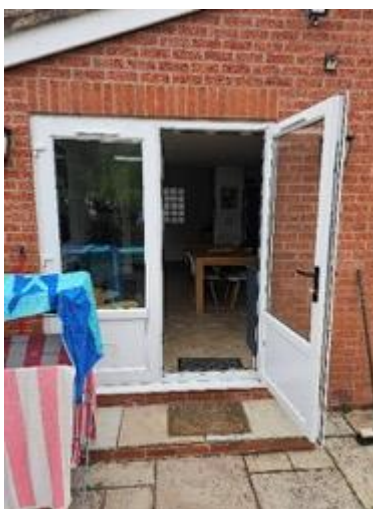
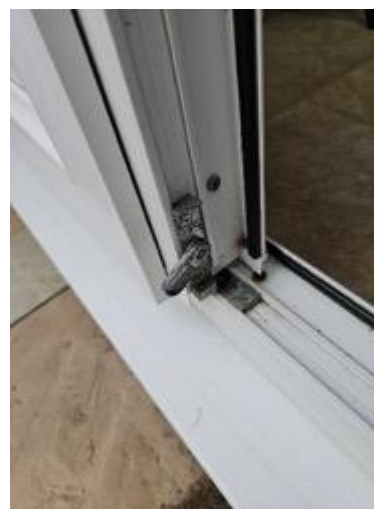
Condition Rating: 2

There is a recessed porch constructed within the external boundary of the property. The ceilings and walls are in satisfactory condition but require redecoration.

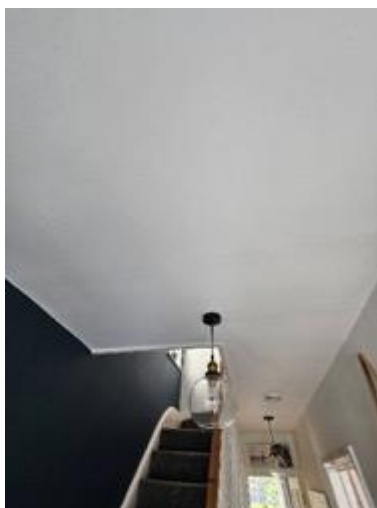
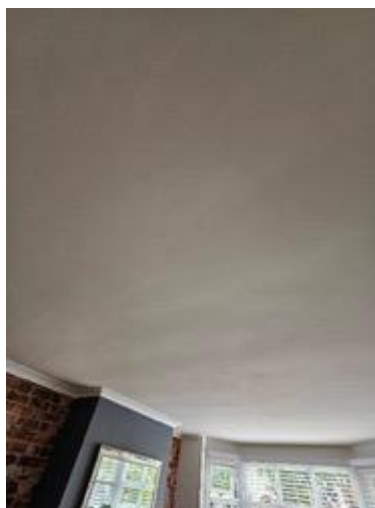
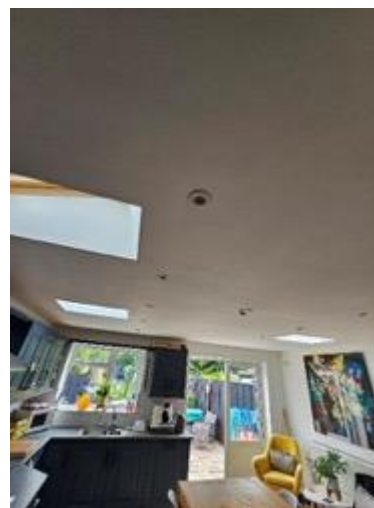
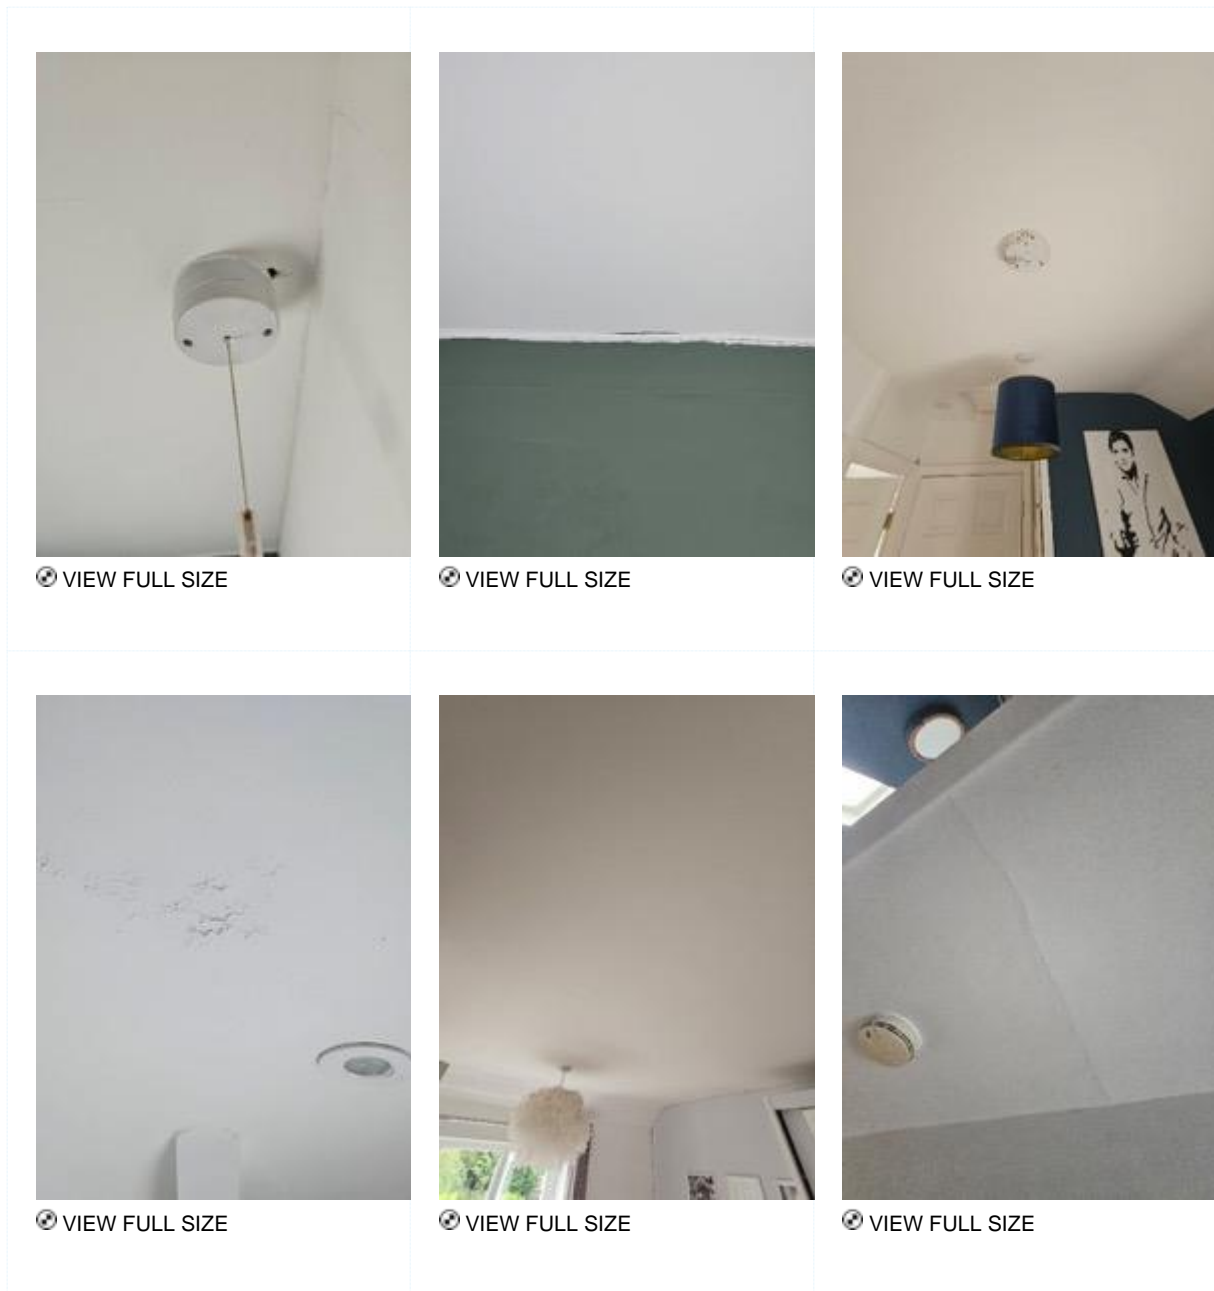
Condition Rating: 2

The general shrinkage and differential movement cracks, mainly visible at the corners and openings, are not of a structural nature and only minor filling will be required, prior to redecoration.

Upon removal of existing decorative surfaces there is a possibility that areas of replastering will be necessary prior to redecorating. It is difficult to confirm the extent of redecoration needed when wall coverings are present, and plaster often requires replacement as finishes are stripped away.

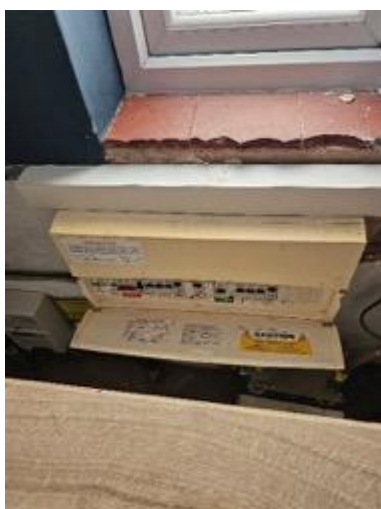
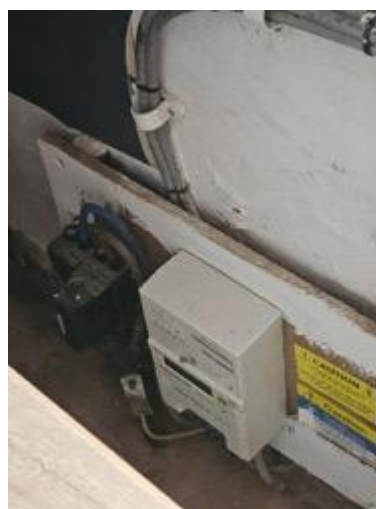
Please note that the Building Regulations stipulate that gas pipes should also be at least 150mm from electrical supply equipment such as electric metering equipment, service cut-outs, main isolation switches or consumer units. We recommend that a GasSafe Engineer comments on the suitability of the current setup.

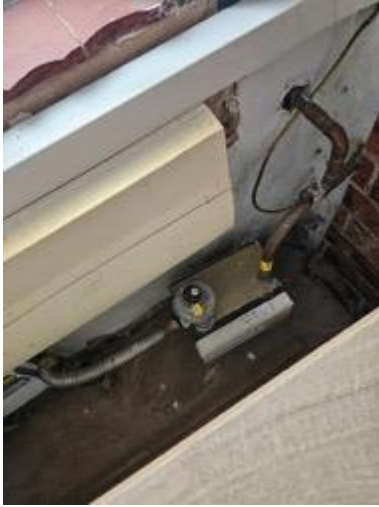
Most of the internal distribution pipework is concealed within the structure or behind fittings and whilst there were no obvious signs of significant leaks, the possibility of concealed defects exists.

The main meter was seen located to the front path

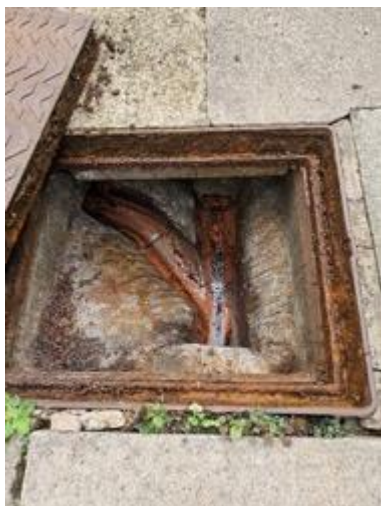
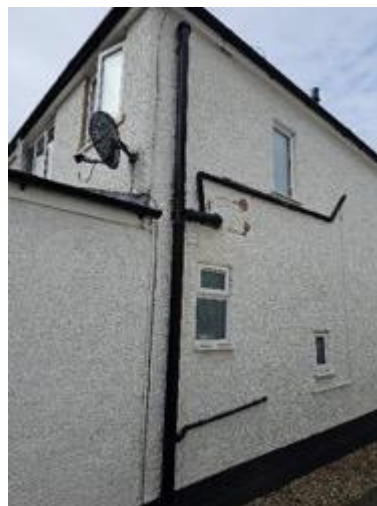
This was seen in reasonable condition with an adequate number of support brackets.

Soil vent pipe termination is more than 900mm above a window which is less than 3m from the SVP. This complies with Building Regulations.

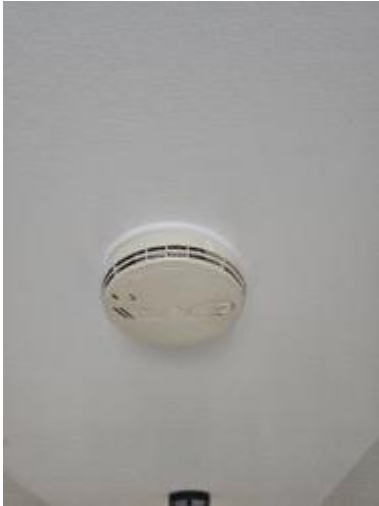
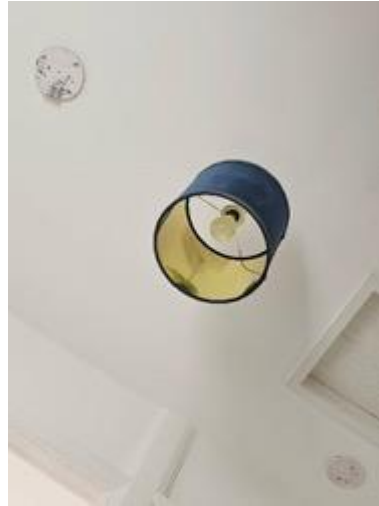
Building Regulations make it mandatory that carbon monoxide alarms are placed near any open flue - i.e. open fire, gas fire and solid fuel / wood burner stove and also by any oil or gas boiler.

Smoke detectors and carbon monoxide alarms have a limited life expectancy; we therefore recommend that new alarms are installed at change of ownership as a life safety system.

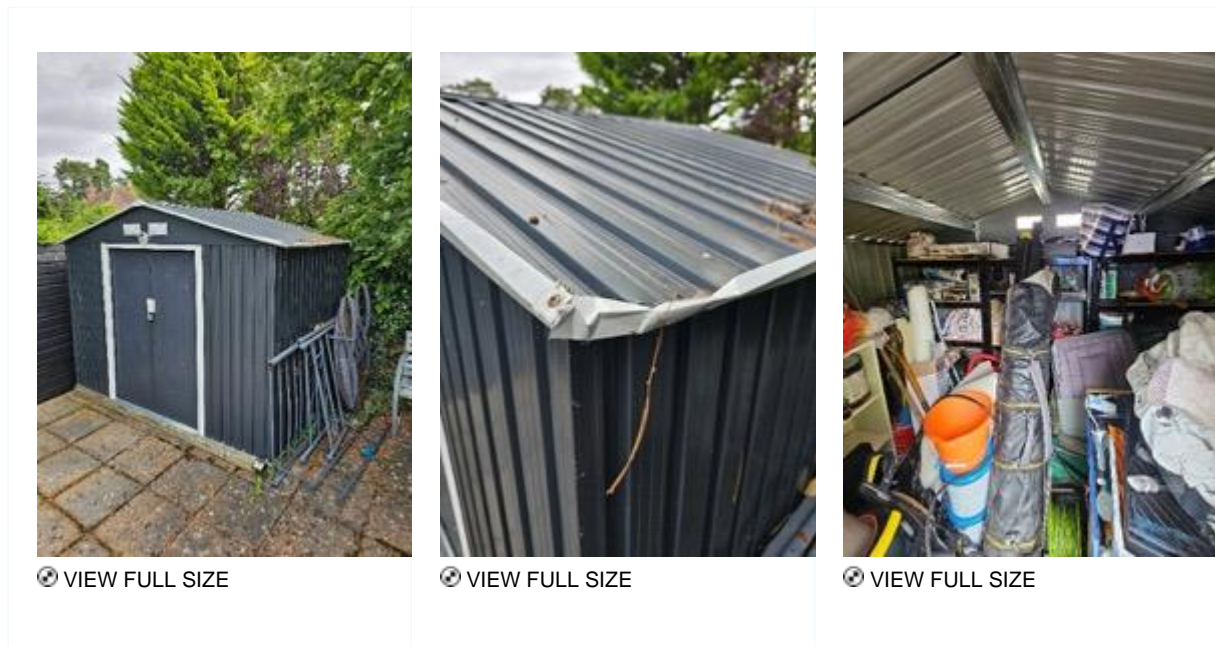
There is a small metal profile shed to the rear of the garden which has signs of impact damage. Generally, it appears in satisfactory condition with no obvious signs of water ingress, but minor repairs are required.
